# THE HOBBS ARMY AIR FIELD: Its History & Archaeology

Final Report  
January 2008

By  
William A. Dodge, Ph.D.

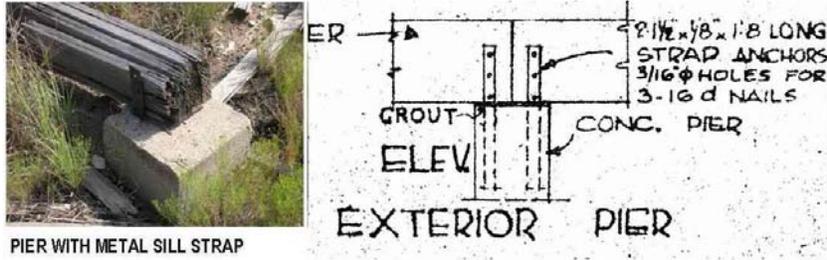
Figure 6: Strap at pier

joists, and in others, bolts were set in the concrete, holes drilled through the sill plate and then a nut attached to hold the sill plate in place (Figure 6). In others the stem wall included anchor bolts to which a wood sill was affixed (Figure 7).

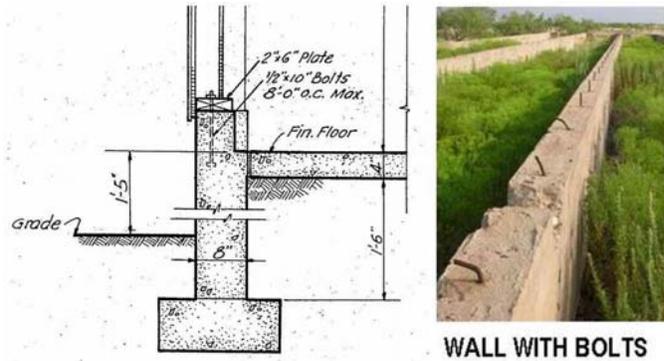
Figure 7: Foundation with bolted sill plate (original drawing and current condition)

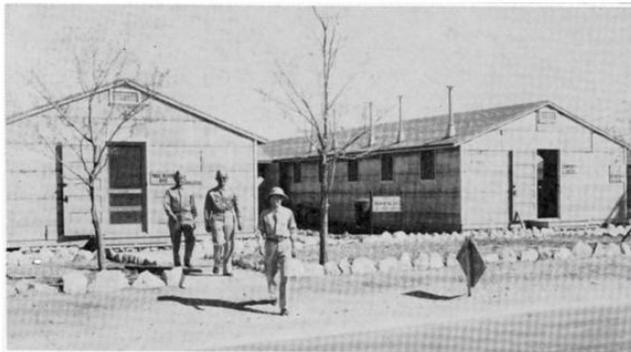
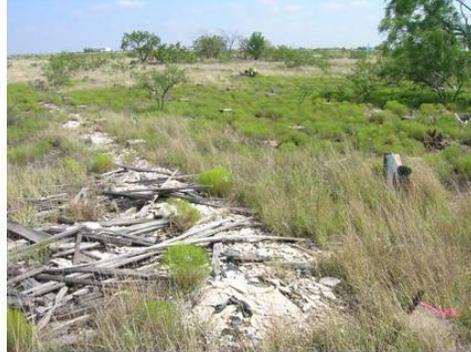
Walls were sheathed with Transite, a composite cement and asbestos board (Figure 8). The buildings had gable roofs covered with rolled roofing. Other structures, such as hangars, warehouses, mechanics shops, lavatories, heating plants, and kitchen areas in the mess halls were built of slab-on-grade to better accommodate heavy work tasks, facilitate sanitary sewers or offer better fire protection. Runways and taxiways were constructed by laying a caliche base, which provided a solid foundation for the B-17 aircraft, surfaced by asphalt and concrete.

BARRACKS WITH TRANSITE SIDING

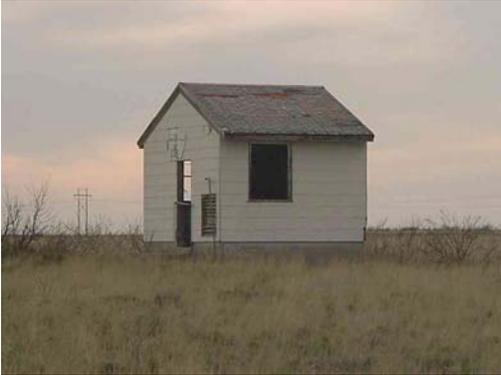
A third type of off-site facility was the radio range. This transmitter radiated coded signals in all directions in order for the aircraft to determine their bearings. It was located three miles due north of the north-south runway (Figure 20).

**Figure 20: Radio Range building, prior to 2007 demolition**

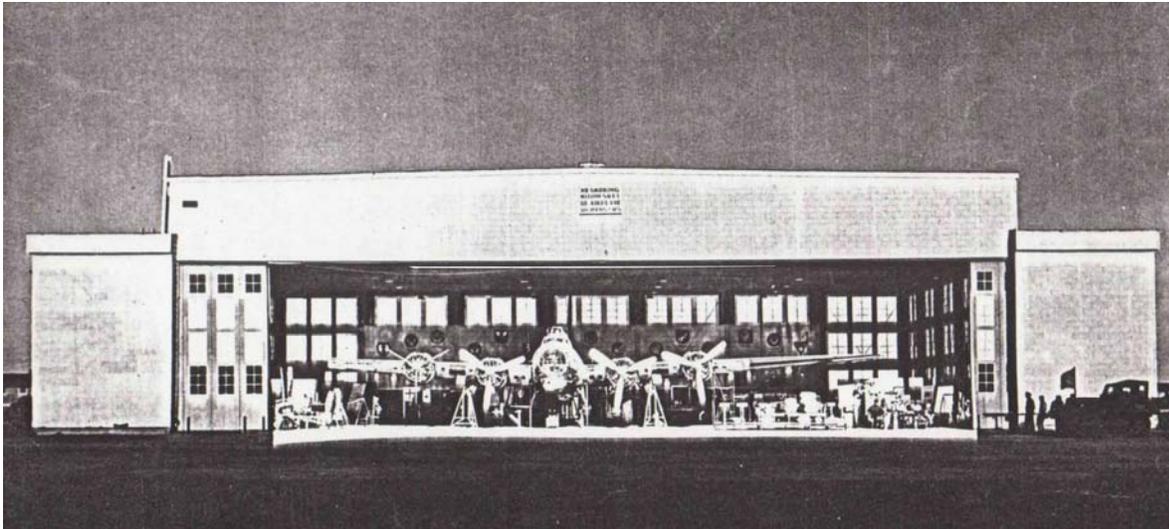
The buildings used for aircraft maintenance were located along the flight line. Each squadron was assigned a maintenance hangar that was situated near that squadron's barracks area for routine maintenance tasks (Figure 29). Larger jobs were carried out at the base engineering shop and its adjacent inspection building/hangar located at the far south end of the flight line. A storage yard was created just to the south of the engineering shop. Other smaller buildings, also located in this area, were constructed for specific maintenance tasks (e.g., the parachute building, propeller shop and instrument repair shop).

**Figure 29: HAAF Maintenance Hangar (Building 272)**

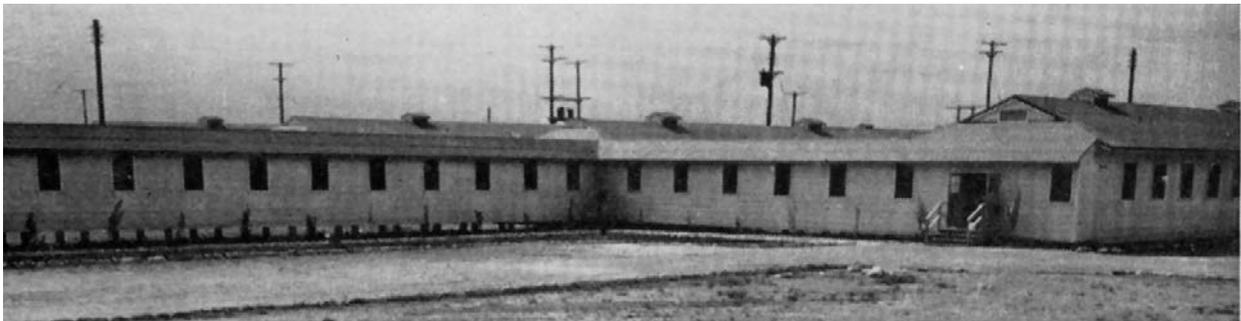
The storehouses and heating plant were served by 25<sup>th</sup> Street and H Street, which intersected G Street on the east side of the area. A covered walkway bisected the hospital buildings north to south connecting the administration building with the heating plant. Enclosed walkways were also built for the south-facing (front) entrances to Buildings 669 to 678 in the third row and Buildings 680 to 687. The enclosures were approximately eight feet wide, built of 2 x 2 lumber supports nailed to concrete piers (Figure 37). Like the adjacent buildings, historic photographs show that the enclosures were sheathed in Transite siding with regularly spaced windows (Figure 38). They were covered by what appears to a shed roof which was probably covered with rolled roofing paper, although this is difficult to see in the photographs. The area was serviced by water, sewer, gas, and electric lines. Outside the covered walkways, gravel

**Figure 38: Hospital Enclosed Walks**

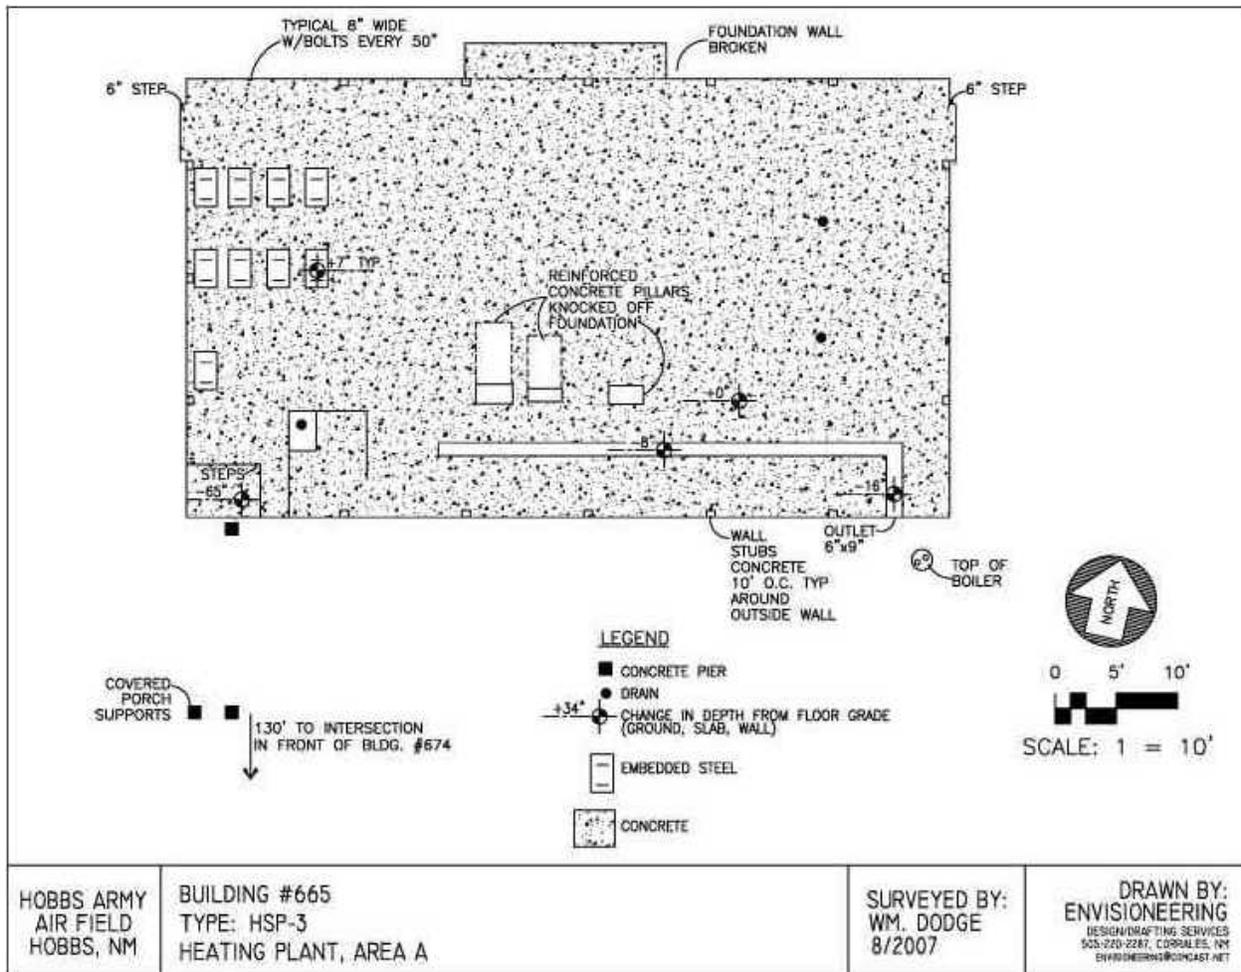
Figure 39: Building 665 sketch map

3. A single slab of reinforced concrete slab sits just south of the parallel rows;
4. A small enclosure, defined by a low concrete stub wall, door opening and floor drain, is located to the east of the pit;
5. Reinforced concrete slab posts, which have been knocked off their foundations, are located in the center of the building – their function is unknown (Figure 40);
6. Two floor drains are situated in the east half of the slab; and
7. A concrete-lined drain is cut into the concrete, running from the south-center of the building to the southeast corner – the slope drops approximately eight inches and outlets in a 6" x 9" opening just below the top of the top of the wall foundation. A boiler, with its top exposed, lies partially buried outside the southeast corner of the structure (Figure 41).

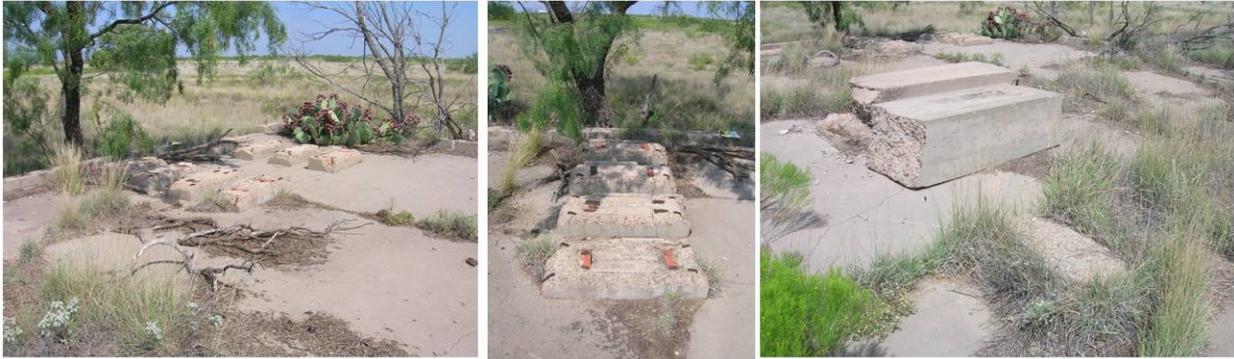
The hospital’s heating plant, a type HSP-3 building, measured approximately 60 by 35 feet (Figure 39). The building was set about 75 feet north of the main hospital complex. It was connected to the main complex by an enclosed walkway that led south from the southwest corner of the building. The framing structure, type of siding, fenestration, and roof shape is unknown. Doorways were on the east and west sides of the buildings, towards the rear wall. What appears to be a concrete slab loading dock is located at the rear of the building. There were a number of interior features:

CONCRETE SLAB WITH BOILER SUPPORTS    BOILER SUPPORT DETAIL    CONCRETE POSTS  
**Figure 40: Concrete features of Building 665, heating plant**

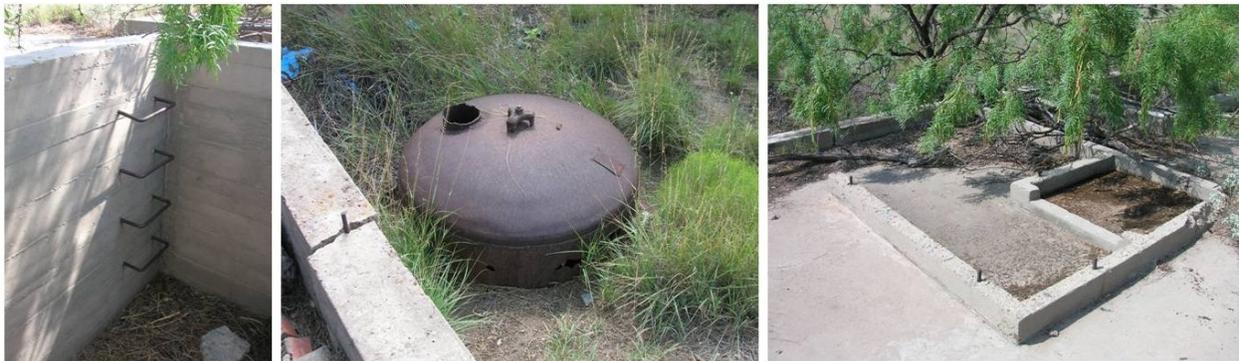
LADDER TO BASEMENT    BOILER TOP    INTERIOR ROOM FOUNDATION  
**Figure 41: Additional features of Building 665, heating plant**

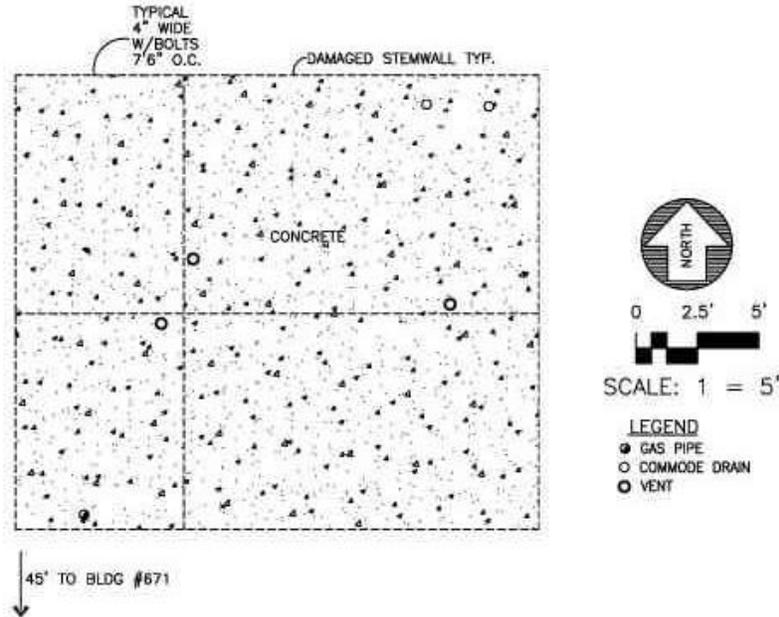
Building 666 is a small lavatory measuring 18 x 12 feet on a slab foundation (Figure 42). It is listed in the base inventory as an L-4 type; however, it is likely that this was a special designation for a hospital L-4 types since there were a total of eight other L-4 lavatories on base that were all larger structures (measuring 32 x 25 feet). The foundation walls on Building 666 are four inches wide with bolts embedded in the concrete. The foundation walls are heavily damaged, which probably occurred when the structure or its interior features were removed. The building is divided into four rooms with two commode drains in the building's northeast corner (Figure 43). There is evidence of vent pipes near the interior walls. A gas pipe rises approximately 10 inches from the floor in the southwest corner.

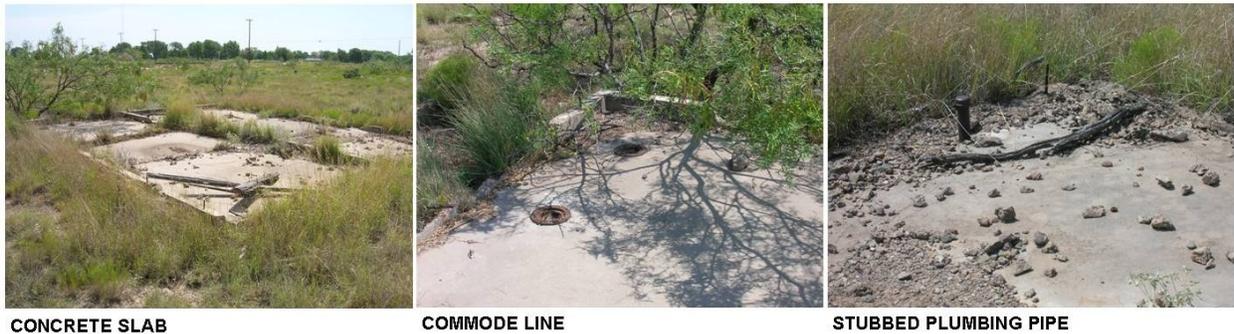
Figure 43: Features of Building 666, lavatory

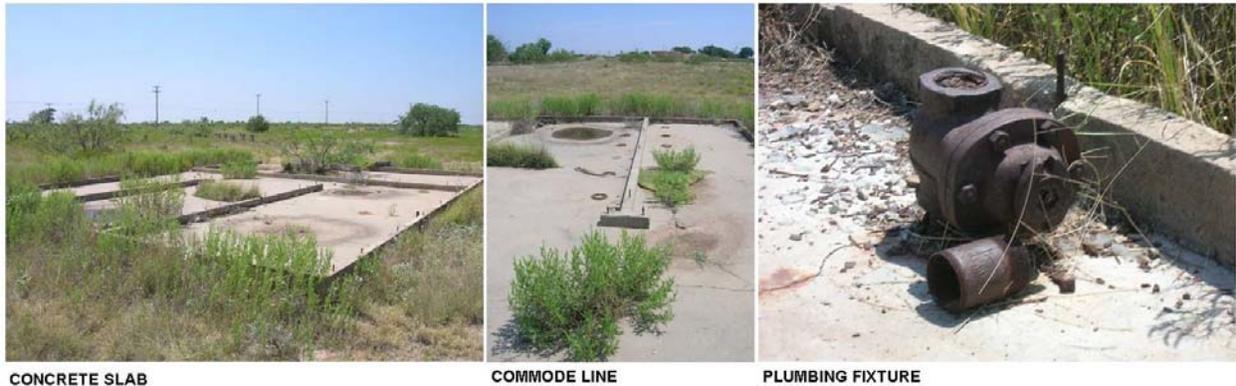
Building 667, a type L-1 lavatory, measures approximately 30 x 20 feet on a slab foundation (Figure 44 and Figure 45). This was the only L-1 type structure located on base and thus may be a type that was associated with hospital complexes. The foundation walls are four inches wide with bolts embedded in the concrete. Finished edges in the exterior foundation walls along the west and south walls suggest these were door openings. The wall sections are

heavily damaged, probably the result of the structure or its interior features being removed. The building is divided into five areas separated by interior walls. Two rows of six commode drains are found in the structure's southeast corner, and the impressions of the toilet fixtures are clearly visible on the concrete slab. Three floor drains are found in the northeast corner, suggesting its use as a shower area. Two additional floor drains are found in the southwest corner room, along with a gas line feature. There is evidence of vent pipes in the three interior walls. The foundations of these buildings are commonly found in squadron barracks areas, indicating that they served male populations on base.

Figure 44: Features of Building 667, lavatory

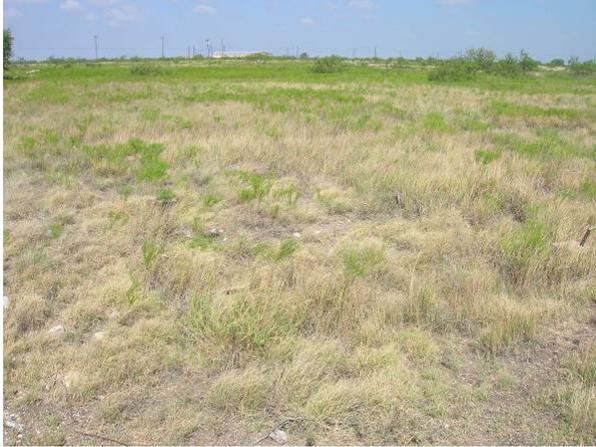
The hospital barracks are type E.M. [enlisted men] 32 buildings, which was the typical enlisted men's barracks style (Figure 46 and Figure 47). The building measures 20 x 60 feet, and was built on concrete piers to which 2 x 2 x 10s were bolted to metal straps embedded into the pier. Porch steps leading into the building were also built on concrete piers. There appear to have been entrances into the building from the north and south, as well as the east in some cases. The south side of the barracks from Buildings 669 to 673 bears evidence of an enclosed walkway in the form of a second row of concrete piers paralleling the buildings six feet apart.

There is evidence of walkways between buildings and lavatories, marked by embedded pieces of white caliche set on end to mark the boundaries of the walkway. Although there are no standing structures remaining at the site, there are piles of Transite siding, dimensional lumber, sheet metal vent sections, and other building parts scattered throughout the area. Gas pipes, sticking up a foot or two from the ground surface, are found outside the buildings along the north side of several structures.

Figure 46: Area of hospital barracks and storehouses from the corner of Building 668, looking east.

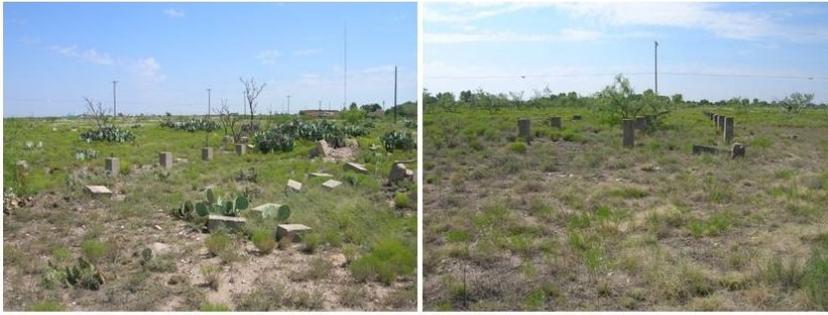
CONCRETE PIERS

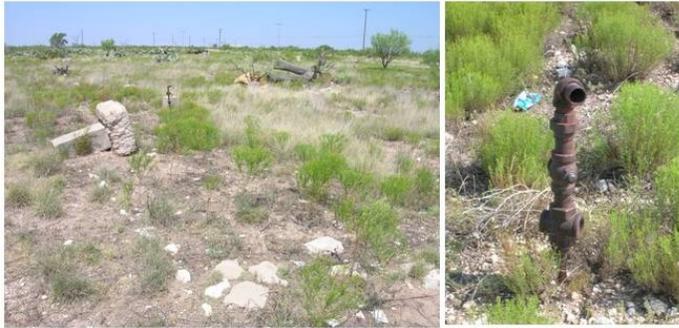
CONCRETE FEATURES

GAS PIPE

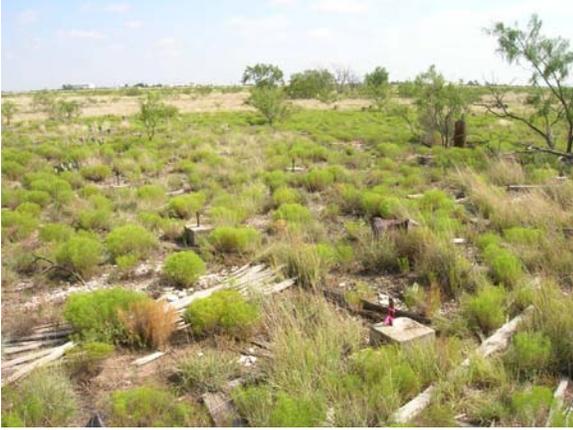
**Figure 52: Building 672 concrete piers and discarded framing lumber, hospital barracks**

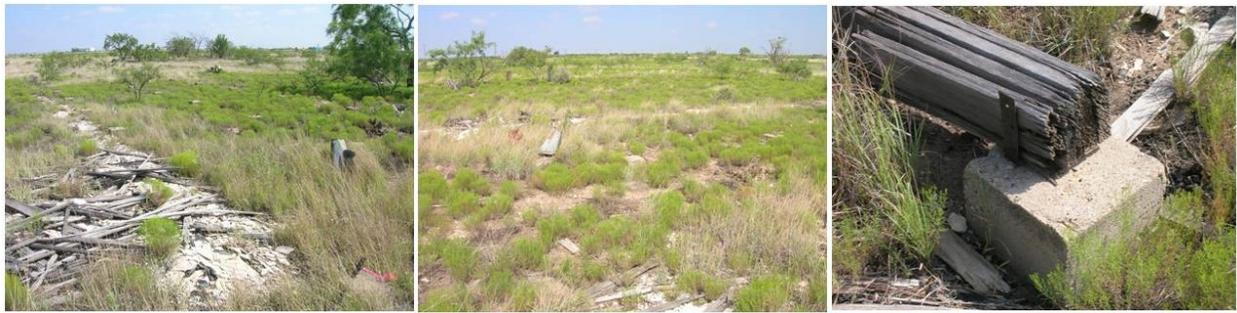
**CONCRETE PIERS AND WOOD REMAINS**

**WOOD AND METAL REMAINS**

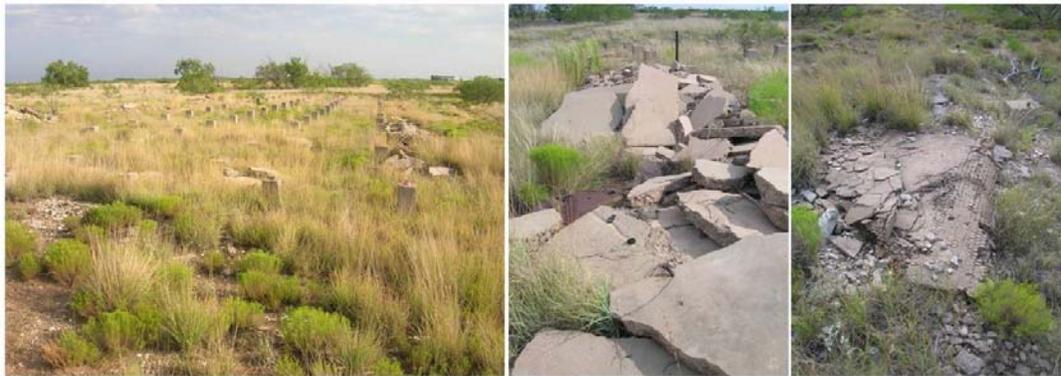
**Figure 55: Features of Building 674, mess hall**

The hospital mess hall measures approximately 40 x 160 feet (Figure 54). There appears to be a small doorway on the north end of the building with steps marked by two piers in the northwest corner. There are few notable features remaining, except the close-set piers marking the enclosed walkway and four close-set piers on the south side that may represent a “front door.” Also noteworthy is the cluster of piers in the northwest corner of the building interior, which may have supported an area of equipment or heavy use (Figure 55).

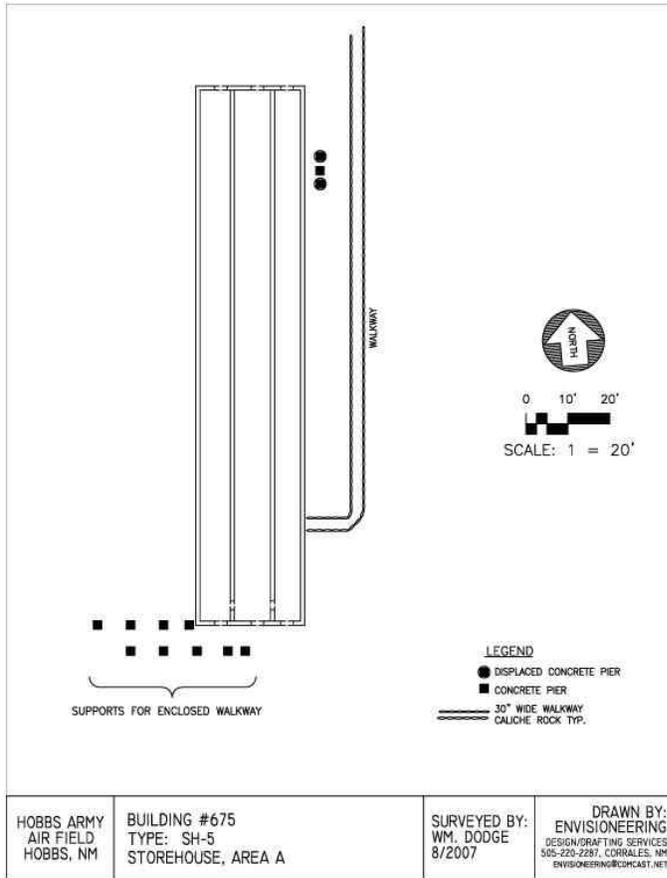
Figure 56: Building 675 sketch map

This discrepancy cannot be explained. Building 675 is built on concrete stem walls that run the length of the building and have sill bolts embedded in the concrete (Figure 57). The end walls of the foundation have been damaged during building tear-down. Porch foundations (concrete piers) are located at the northeast corner of the building and a caliche lined walkway leads to the southeast corner, suggesting another entryway.

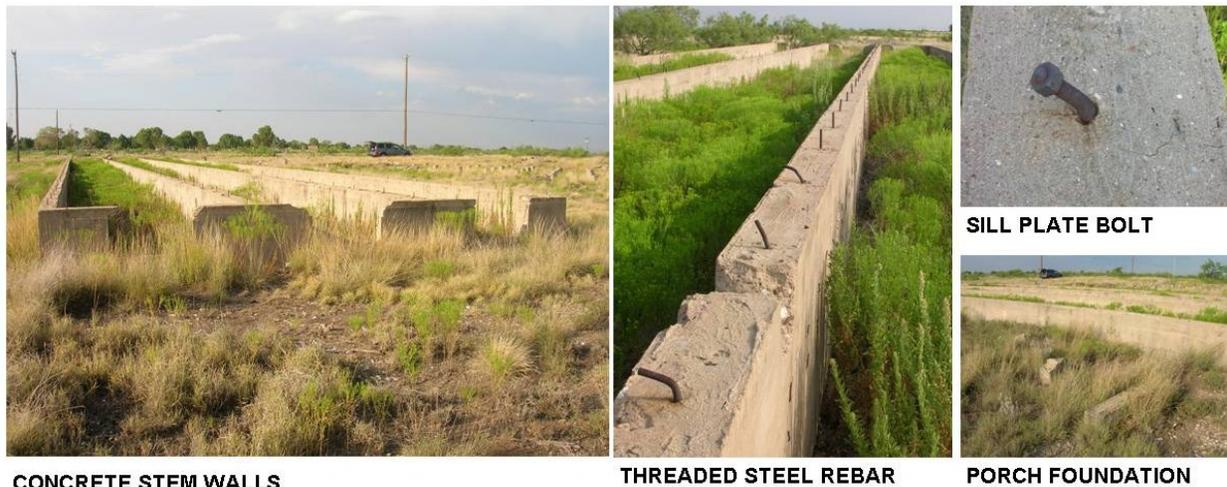
CONCRETE STEM WALLS  
 THREADED STEEL REBAR  
 SILL PLATE BOLT  
 PORCH FOUNDATION  
 Figure 57: Features of Building 675, storehouse

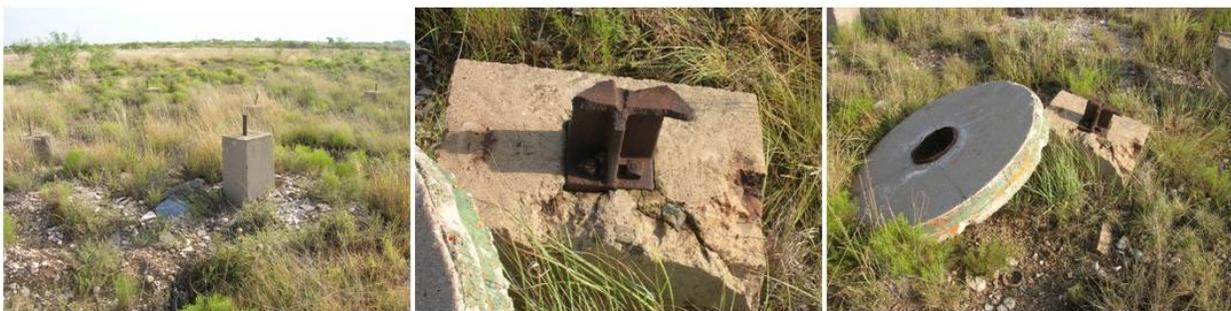
CONCRETE PIERS

STEEL I-BEAM

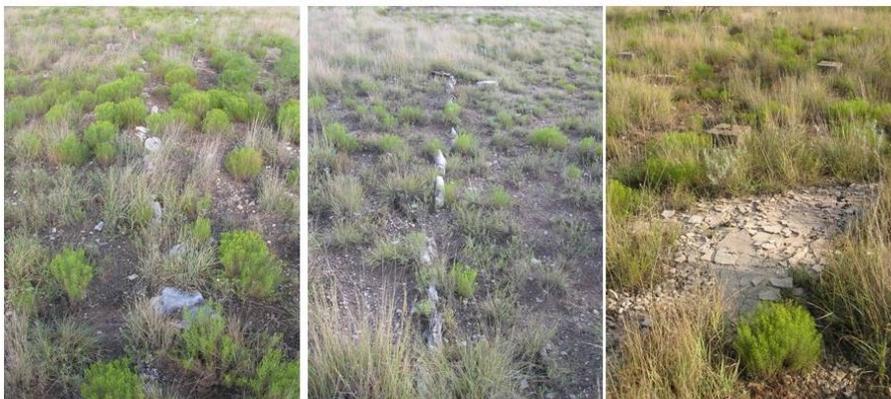
Figure 61: Features of Building 677, storehouse

CALICHE WALKWAY      WALKWAY ROCK BORDER      TRANSITE SIDING & PIERS

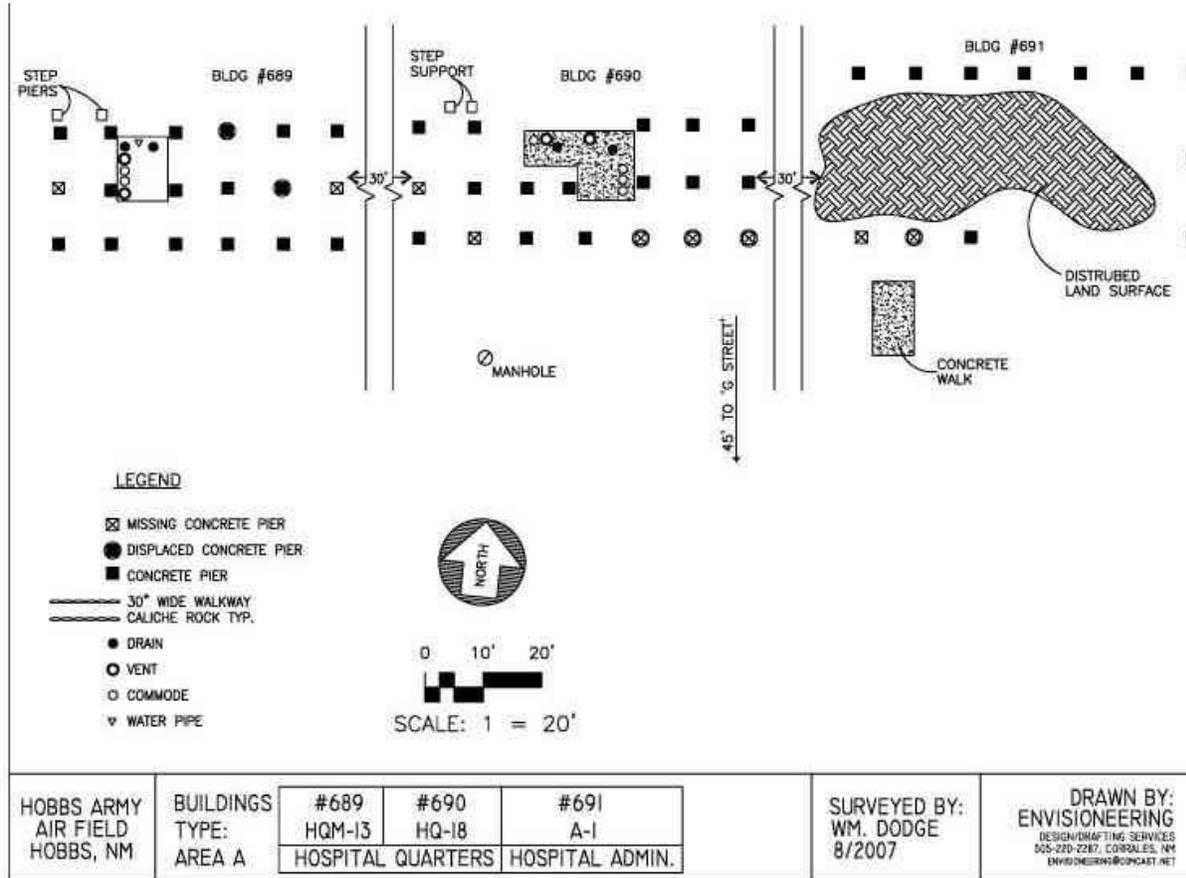
Figure 62: Building 689, 690 and 691 sketch map

The remains of these two buildings have been greatly disturbed by heavy equipment, making their identification difficult. The buildings were originally similar in form, each measuring approximately 20 x 50 feet (Figure 62). The only remaining feature in either building is the lavatory, which are concrete slabs raised a few feet above the ground surface (Figure 63). Each lavatory features commode drains, and floor drains suggesting shower areas.

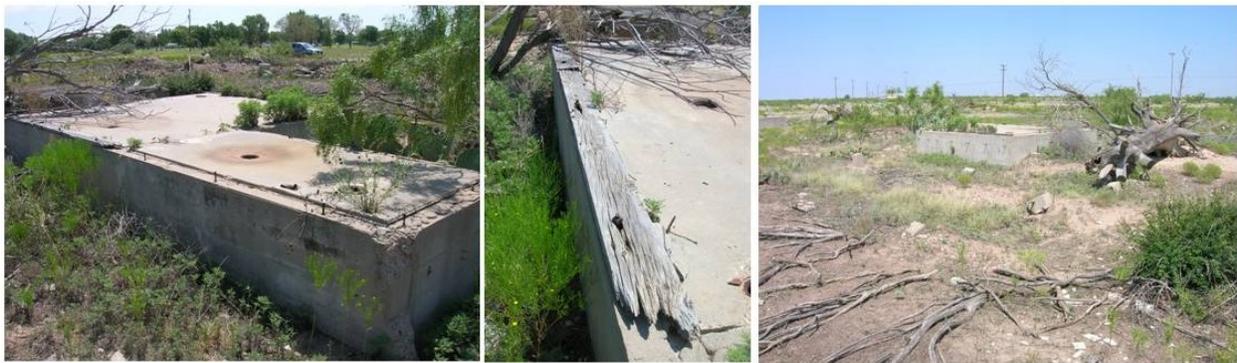
CONCRETE STEM WALL & FLOOR      WOOD SILL PLATE      FOUNDATION  
 Figure 63: Features of Building 690, hospital ward indoor lavatories

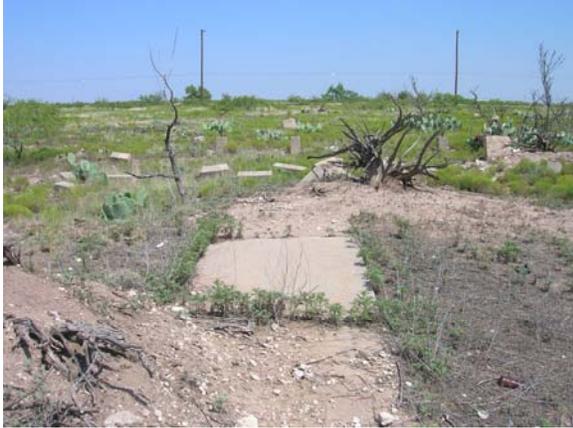
**Figure 64: Remains of entrance walkway**

The remains of the hospital administration building have also been heavily disturbed, resulting in a slight depression where the center of the building would have been. The building measures approximately 25 feet wide, but its length could not be determined due to disturbance (the 1943 plans indicate the structure was 150 feet long). The only remaining feature is a concrete walkway that led from the parking lot along G Street to what would have been the building's front door (Figure 64). Historic photographs of this building show a screened-in front porch with a shed roof and low monitors on the gable roof (Figure 65).

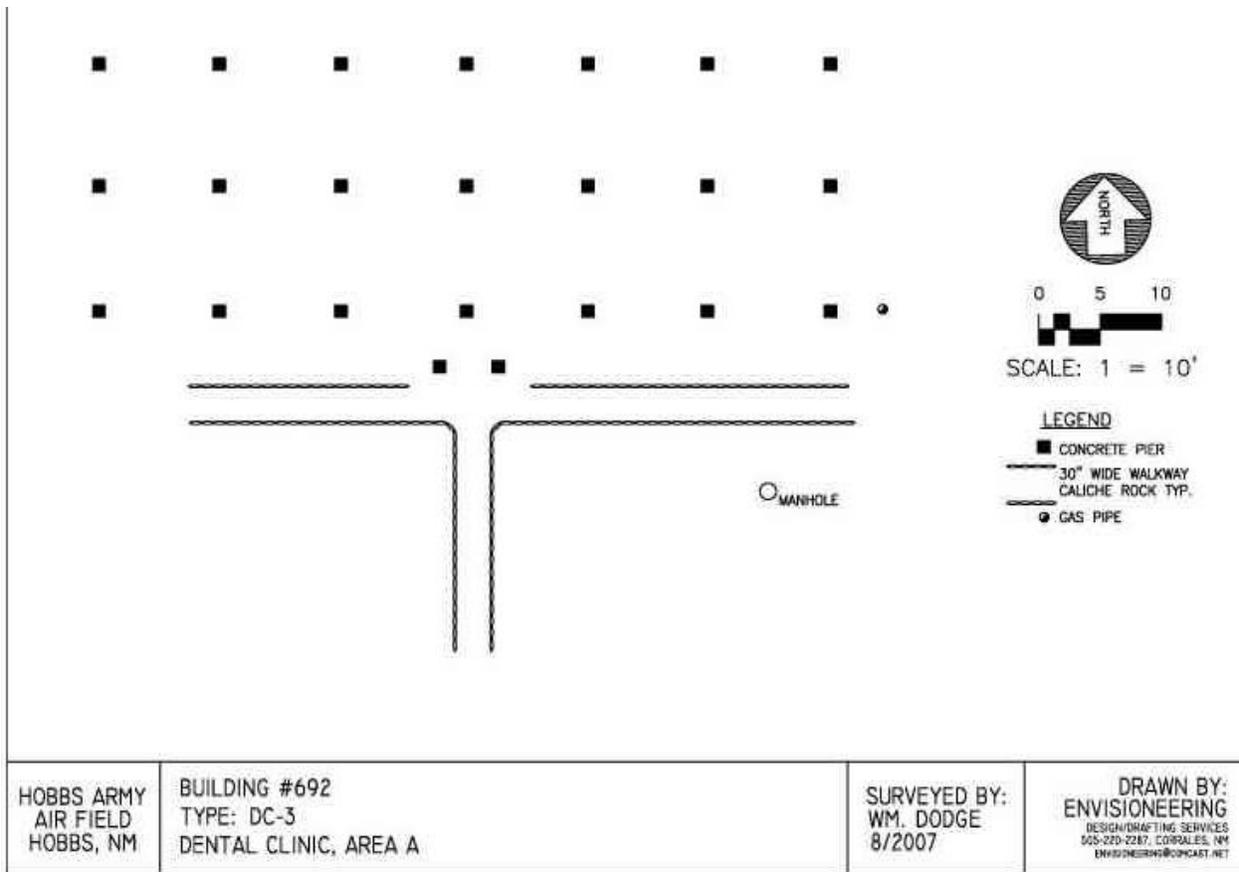
Figure 66: Building 692 sketch map

The dental clinic was heavily disturbed; however, the building appears to measure 20 x 80 feet (Figure 66 and Figure 67). A porch, supported by piers, entered the building along its south side in the center of the building (Figure 68). Caliche-lined walkways are clearly visible on the south side.

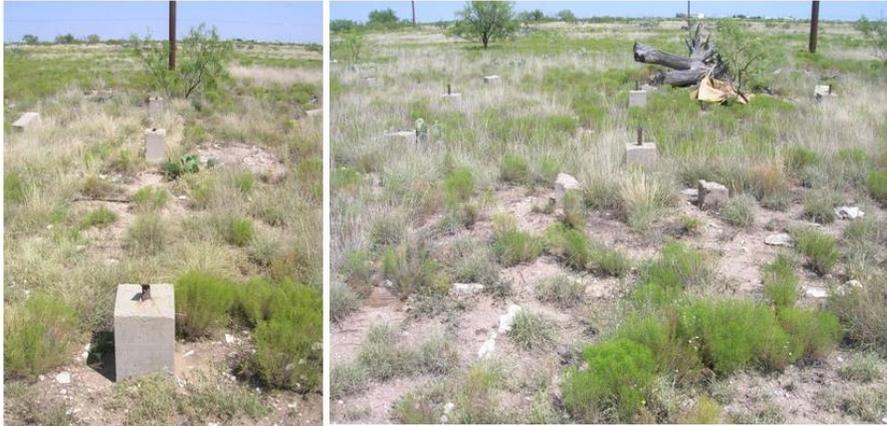
CONCRETE PIERS

CONCRETE PIERS AND DEBRIS

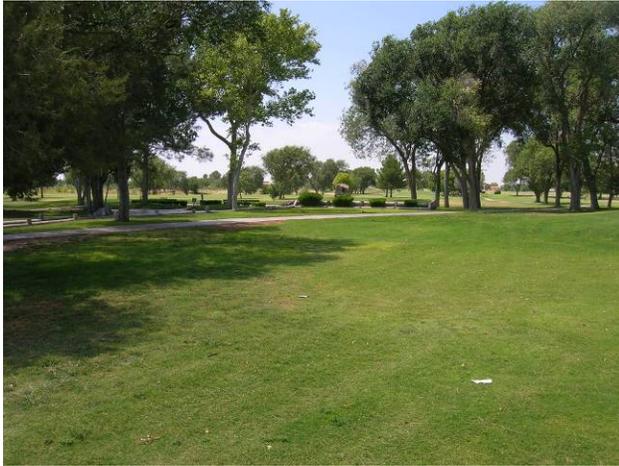
Figure 70: Area B, former location of officer's quarters, dining room, and officer's club

In the 1960s, 18-hole golf was built in this area (Figure 70). All remaining buildings and foundations were removed, and the terrain was reconfigured for the course layout. Although it

was thought that the officer's club was remodeled into a pro shop and clubhouse, this proved not be the case. Overlays of the original base layout over a contemporary aerial photo show that the present day golf course facility is located in the barracks section of the former Area B, well to the north of the mess hall and officer's club. An interview with a former soldier stationed at HAAF confirmed this observation, as did an examination of the pro shop itself, which showed that the building was constructed of materials (i.e., concrete masonry block) that were not used for HAAF buildings.

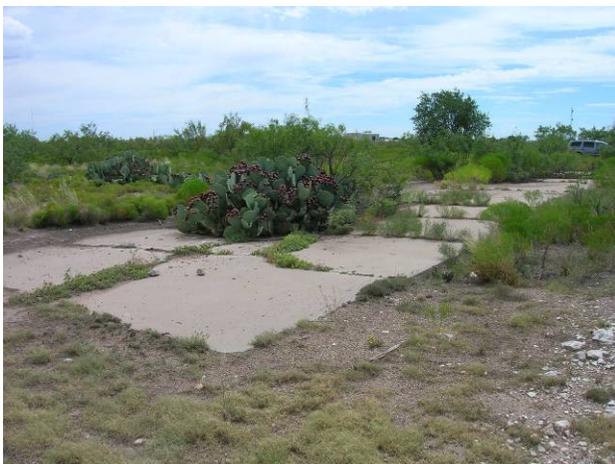
**Figure 72: Features of Building 523, wash rack**

The remains of the wash rack consisted of a concrete slab at grade, measuring 25 x 125 feet (Figure 72). Six water spigots, set in clay pipe just below the ground surface, lined either side of the slab. It is not known whether the rack had walls or a roof.

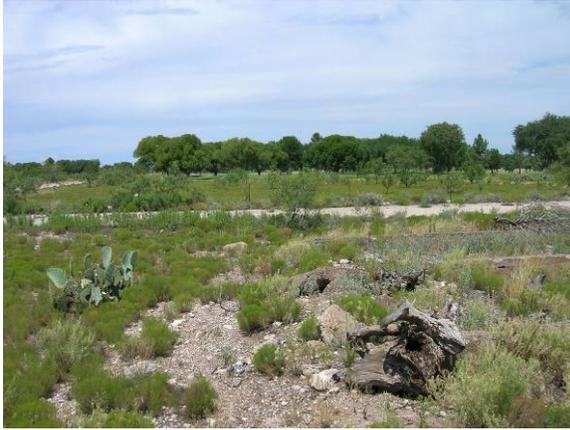
**Figure 74: View to the northwest of Area D near the intersection of 15th Street and C Street.**

The area from C Street to E Street, between 14th Street and 16th Street, was disturbed by golf course construction (Figure 74). The foundations of other buildings in the squadron sections have also been disturbed. One exception was Building 446, a type L-1 lavatory. Most of the dirt and gravel roads in the NE part of the area have been re-bladed adjacent to their original alignment to accommodate the golf course.

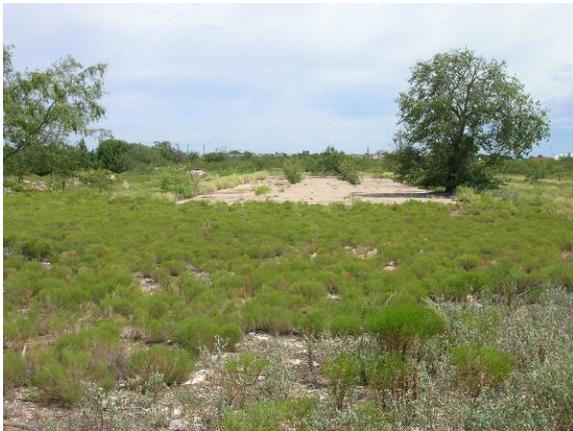
All that remains of this warehouse is a flat concrete slab (Figure 75). This is typical for all the warehouse structures at the base.

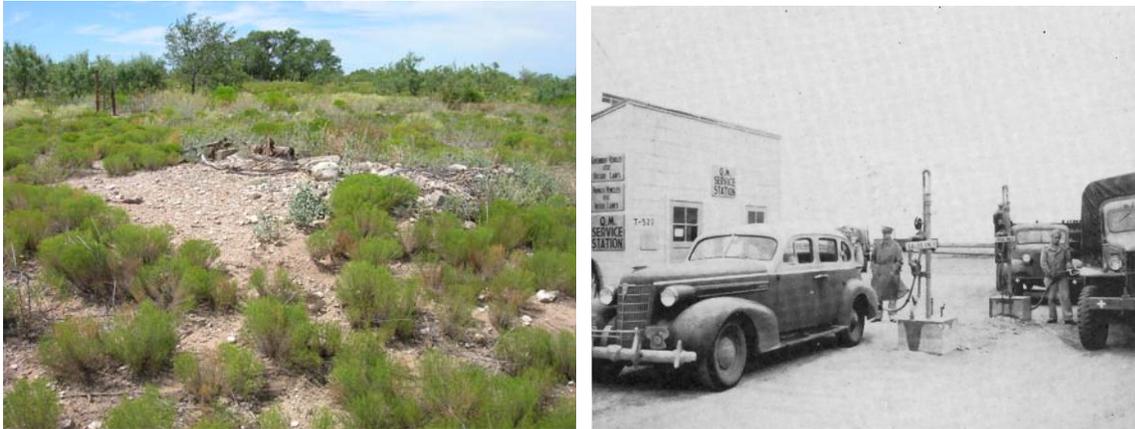
**Figure 76: Remains of the gas station and view of station from the 1940s**  
 Source: Field photo (left) and U.S. Army Armed Forces Yearbook (right)

The gas station sat at an angle to the intersection of 18<sup>th</sup> and D streets. A pile of concrete rubble and piping are all that remains of this building (Figure 76).

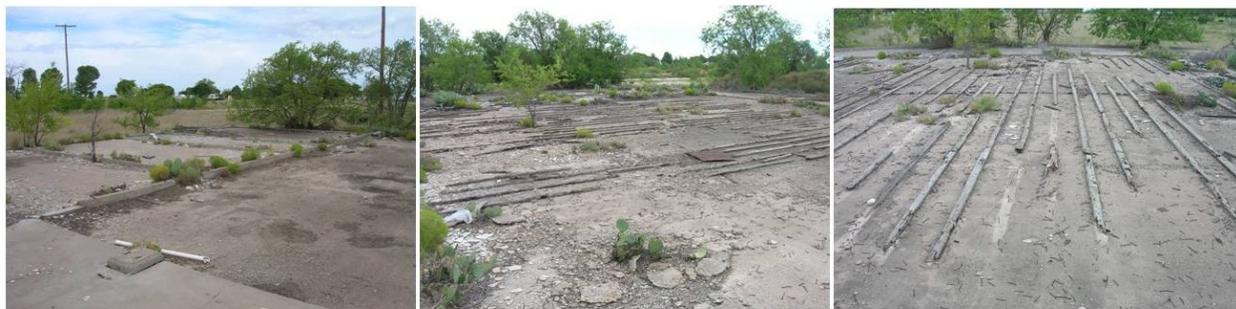
The base gymnasium was completed in mid-year, 1943. The building measured 75 feet by 175 feet and featured a full-sized basketball court and handball courts (Figure 78). Remnants of the hardwood floor sub-flooring still sits on the concrete slab. The main entrance appears have been at the southwest corner of the facility through a small vestibule that lead to the courts and the bathroom and shower areas. To additional side entrances were located adjacent to the handball court area (Figure 79). The basketball court was flanked by rows of concrete piers, presumably as roof supports. The west side of the building was separated into four room containing two lavatories and a shower stall. The two rooms in the middle may have contained lockers or a dressing area.

LOCKER ROOM FOUNDATION

WOOD SLEEPERS AT GYM FLOOR

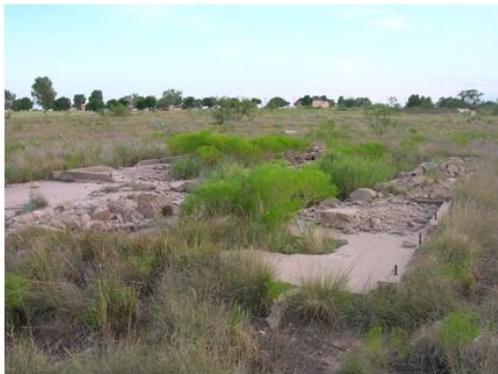
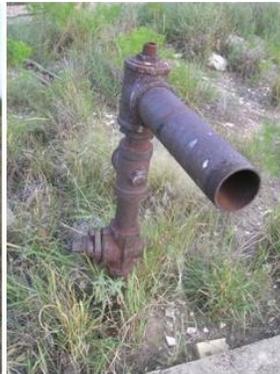
**Figure 83: Features of Building 18, lavatory**

The type L-4 lavatory measures 32 x 25 on a concrete slab and features interior partitions to separate the different use areas and mechanical equipment (Figure 83). Like the L-1 type it has two rows of six commodes (see Section 4.1.3).

**CONCRETE FOUNDATION**

**PIPE STAND**

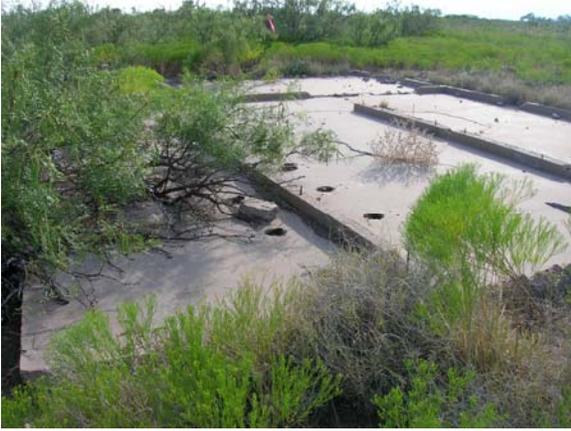
**Figure 86: Features of Building 31, lavatory**

This lavatory type is similar in layout to the type L-1 (see 4.1.3); but housed in a larger building (32 x 25 feet) (Figure 86 and Figure 87). They were associated with the cadet's barracks.

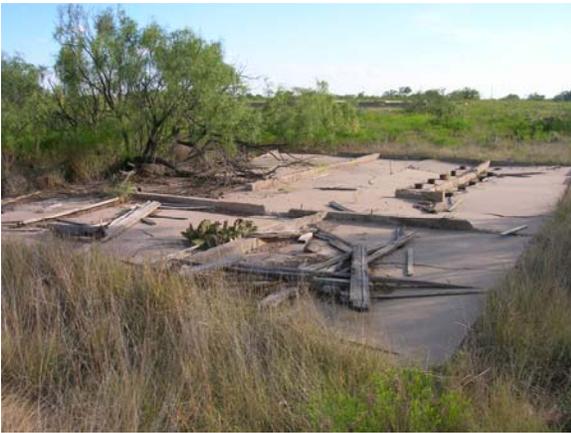
**Figure 87: Building 36 concrete foundations and boards, lavatory. Note commode drains in the right center of the photograph.**

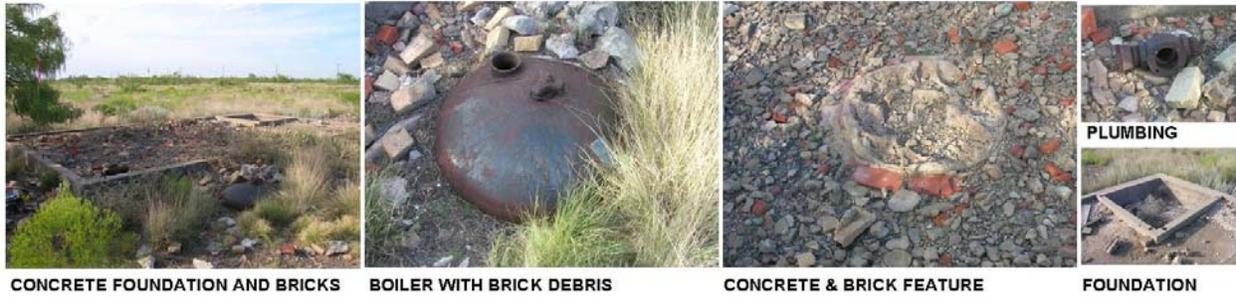
Figure 89: Features of Building 37, mess hall

The slab had several other features of unknown function (Figure 89). There was circular concrete feature that was almost level with the slab floor. It was surrounded by brick fragments. There was also a concrete lined subterranean pit, 24 inches deep, with an iron slab on the floor. Metal pipes rose through the stem walls of the pit. Other gas pipes were found associated with the slab. A smaller concrete slab was located adjacent to the larger slab on the east. It was covered with dimensional lumber. The remainder of the building consisted of concrete piers, many of them missing. The building measured 100 by 70 feet.

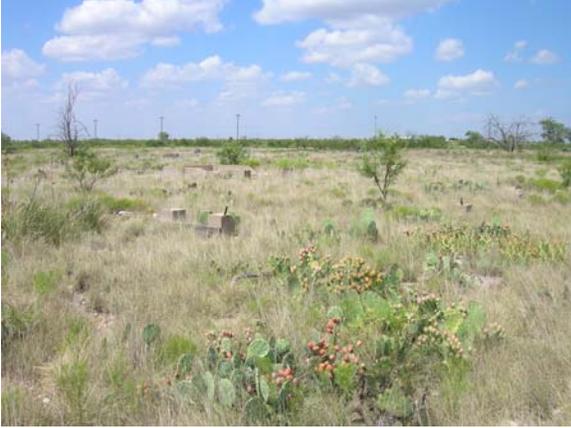
**Figure 91: Features of Building 651, WAAC Administration, Recreation & Supply**

Building 651 is represented by concrete piers indicating an L-shaped building with a concrete slab and entryway where the two section of the L join (Figure 90 and Figure 91). Two additional entrances are situated on the long axis of the building.

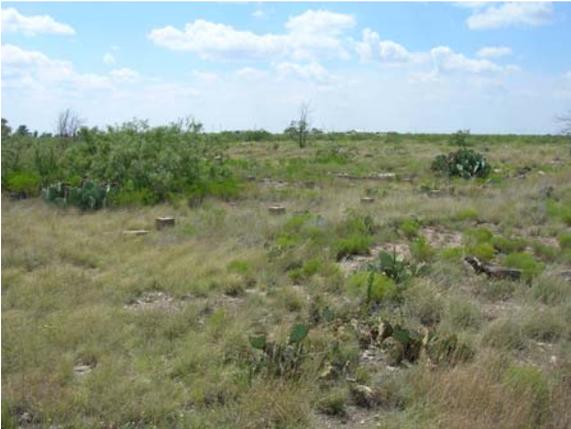
**Figure 92: Features of Building 652, WAAC Barracks**

The WAAC's barracks were differentiated from the enlisted men's barracks by the fact that they were the only 2-story barracks on base and featured indoor plumbing (Figure 92 and Figure 93). They consisted of a concrete slab platform (approximately 30 x 50 feet, 16 inches above grade), adjoined by a series of concrete piers measuring 20 x 40 feet coming off the southeast side of the building (see Figure 90).

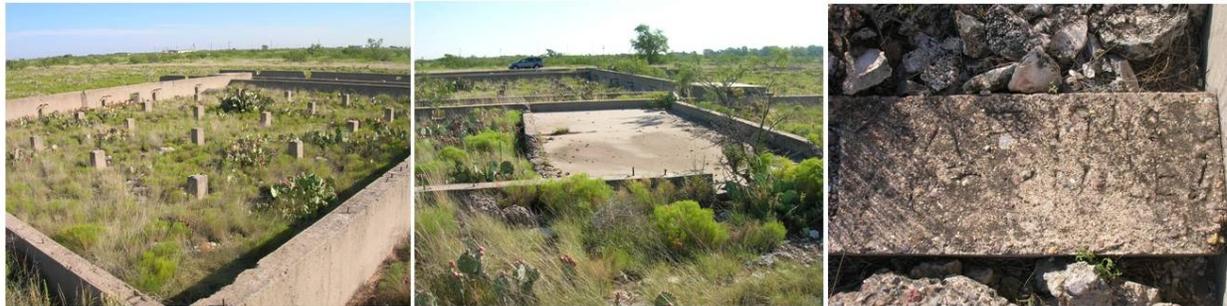
CONCRETE STEM WALL AND PIERS      CONCRETE FOUNDATION      1940s GRAFITTI

Figure 97: Foundation features of Building 62, School

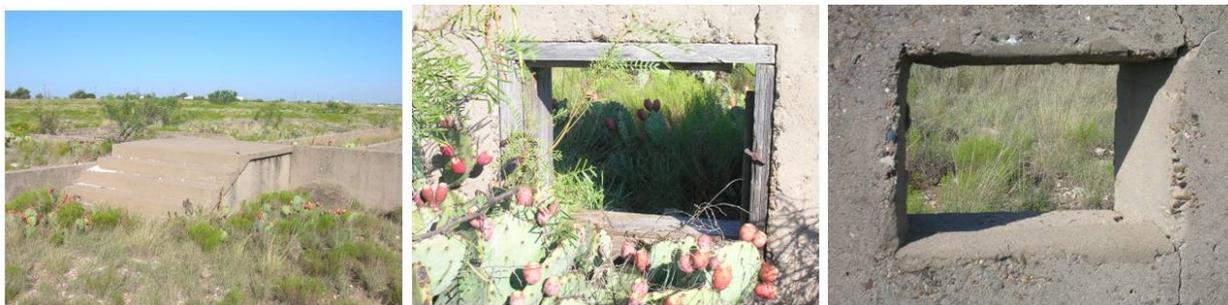
Figure 98: Architectural features of Building 62, cadet training school

These two identical buildings were used for cadet training classrooms. They were built on stem wall foundations that were raised 38 inches above grade in the center of the structure and featured rectangular wings on east side of the building which were built at grade (Figure 96 and Figure 97). Four sets of concrete steps provided access to the center of the building. Openings cut into the foundation walls suggest the presence of a crawlspace or low basement (Figure 98). One-half of the openings were slightly larger, set lower below the top of the stem walls, and were framed with dimensional lumber (Figure 99).

CONCRETE STAIRS      WINDOW      FOUNDATION OPENING

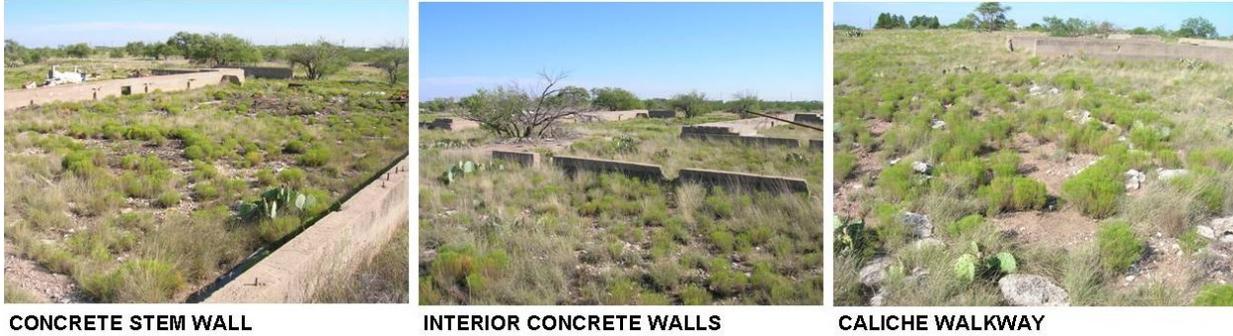
**Figure 99: Features of Building 66, cadet training school**

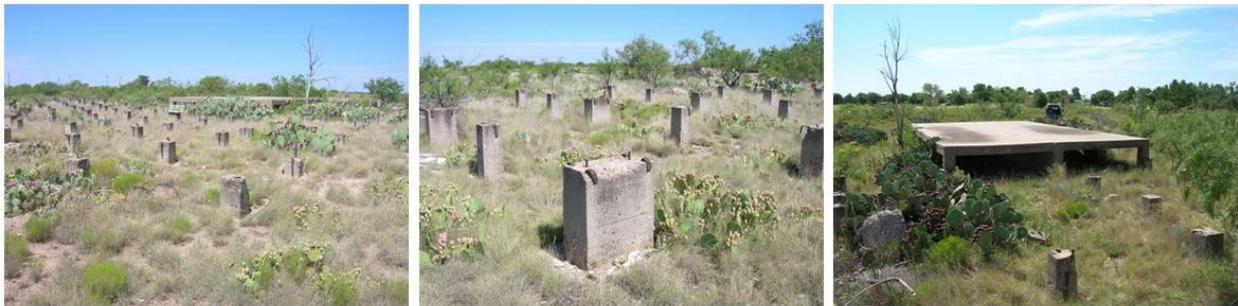
Building 75 is one of the largest remaining foundations on the HAAF, measuring 215 x 180 feet (Figure 100). The building was constructed on concrete piers except for a raised concrete slab platform in the center of the structure (even in height with the surrounding piers) and a concrete slab at grade at the building’s northwest corner, which was presumably the kitchen. The piers at the southeast corner of the structure are spaced more closely together suggesting an enclosed porch over the main entry. Some piers on the building’s wings are larger in diameter than adjacent piers indicate the need to carry a heavier load (Figure 101). The supposed kitchen area is separated from the main building by about 25 feet. Its slab measures 40 x 25 feet and has a wide sloping concrete ramp on its southwest side. Several internal features were found including a raised concrete slab with brick inlay, bricks lay on the slab, and grooves cut the slab at grade. Gas lines entered the area from the northeast and a large unidentified slab, standing 45 inches high was situated just outside the stem wall foundation (Figure 102).

CONCRETE PIERS

RECTANGULAR PIERS WITH STRAPS
