# THE HOBBS ARMY AIR FIELD: Its History & Archaeology

Final Report  
January 2008

By  
William A. Dodge, Ph.D.

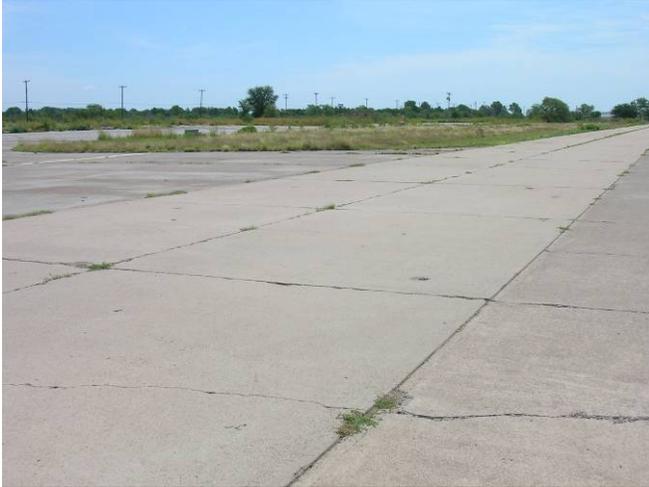
demolished, but the rails for large, sliding hangar doors are still embedded in the concrete. All concrete parking aprons are still in place (Figure 105).

**Figure 105: View to the southeast of the parking apron and Area J. The concrete apron in the center of the photo was used for moving aircraft through the Air Command hangars for maintenance. The power lines in the background run parallel to A Street.**

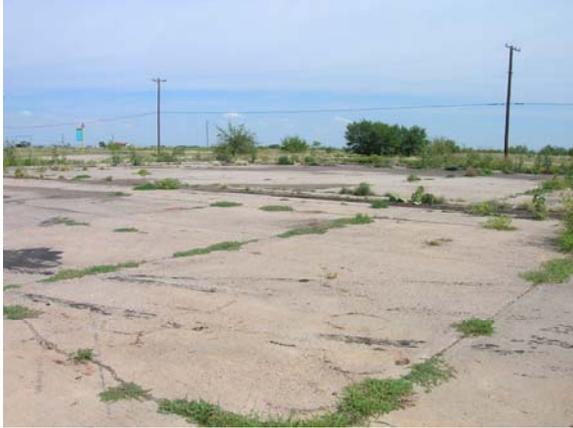
**Figure 106: Concrete slab of Building 201, bomb trainer**

The bomb trainer buildings were large, 2-story hangar-like buildings that faced the aircraft parking apron. They measured 95 x 95 feet square and were constructed on a concrete slab with six rooms aligned against the back wall (Figure 106 and see Building 211 figure). The rooms were 12 feet wide of varying lengths and probably housed offices and a lavatory. The front of the building featured a four-rail track across the width of the building which moved the two, full-length sliding doors (Figure 107). The mechanisms for controlling the doors were located at either end of the rail.

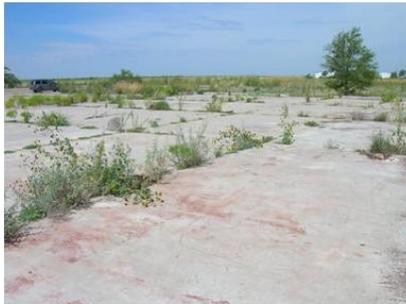
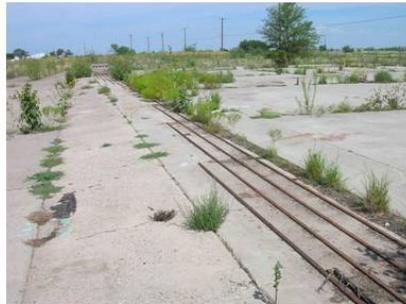
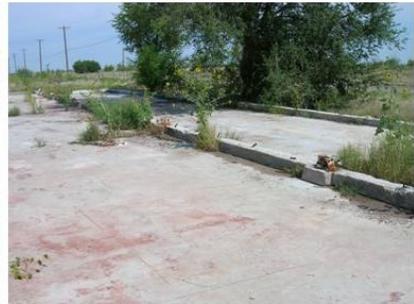
**Figure 107: Concrete features of Building 202, bomb trainer**

**CONCRETE SLAB**

**STEEL DOOR TRACKS**

**STEM WALL FOR REAR ROOMS**

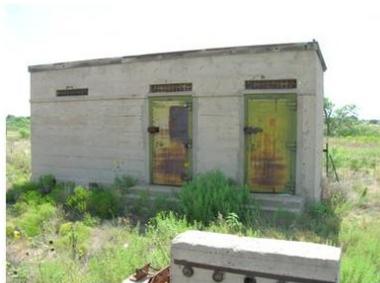
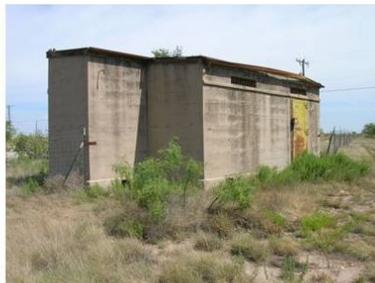
**Figure 108: Concrete features of Building 203, bomb sight storage**

These two conjoined buildings are concrete vaults designed to store top-secret equipment (Figure 108). The heavy, steel door for Building 203 faces south, while Building 204 has two similar doors facing north. The shed-roofed structure has no windows but does have rectangular air vents spaced across the top of the wall.

**NORTH ELEVATION**

**STEEL DOOR**

**CONNECTION OF 203 & 204**

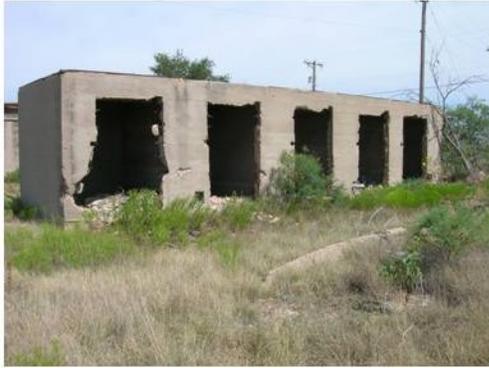
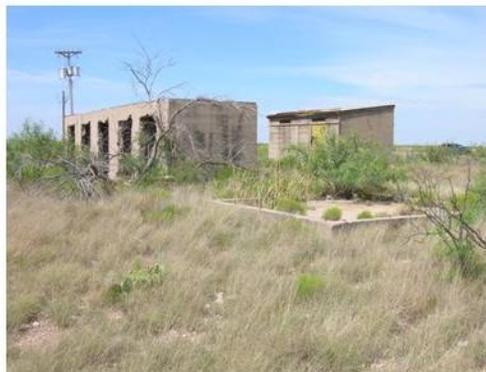
**Figure 109: features of Building 205, bombsight storage**

This model of storage building has four vaults with their entryways facing south. Each of the entryways has been demolished, leaving gaping holes in that side of the building. The building has a shed roof with no other openings (Figure 109).

**SOUTH ELEVATION**

**RELATIONSHIP TO 203**

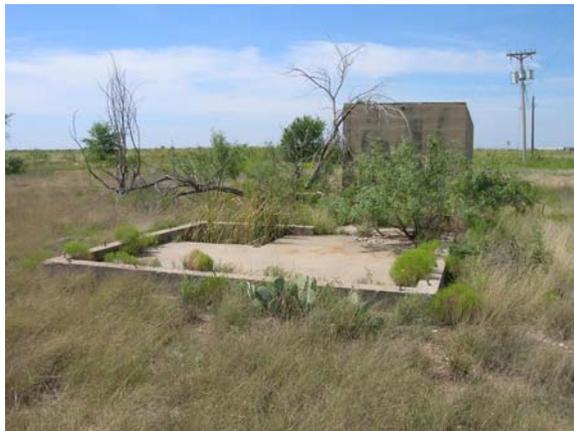
The rectangular foundation of a small boiler house is located to Building 205 (Figure 110). It features a rectangular subterranean concrete-lined pit in its southwest corner. According to historic documents it is said to have provided heat for Building 205 (TL 2005: Appendix B).

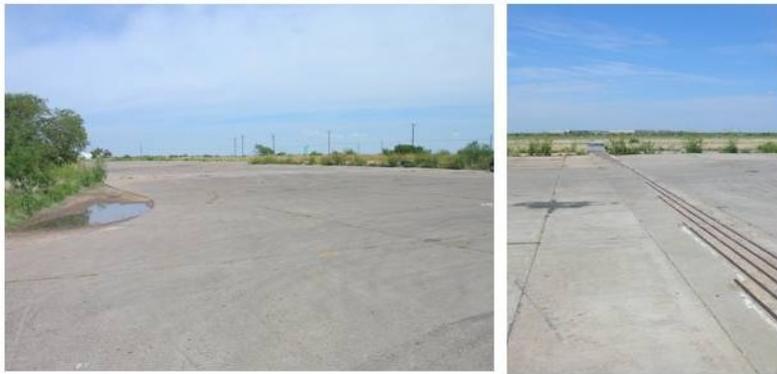
**Figure 112: Concrete features of Building 272, A.C. Squadron Hangar**

Figure 111 is an elevation showing the architecture of the A.C. Squadron Hangars. All that is left of the large squadron hangars are the concrete pads where the building used to sit and the tracks for the massive sliding doors (Figure 112 and Figure 113).

**APRON IN FRONT OF BUILDING      STEEL DOOR TRACKS**

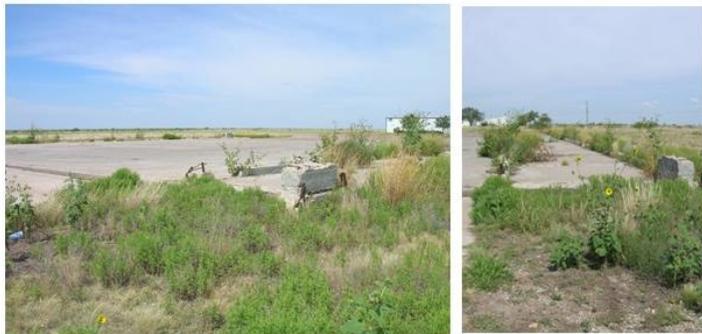
**Figure 113: Concrete features of Building 274, A.C. Squadron Hangar**

**CONCRETE CLAB & DOOR TRACKS      SLAB DETAIL**

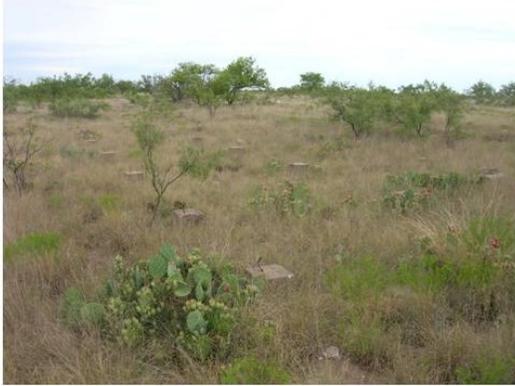
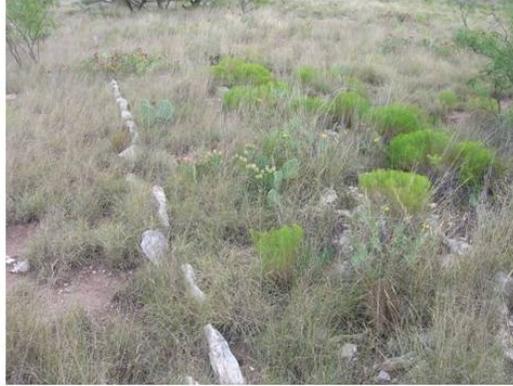
**Figure 116: Concrete slab and stem walls of Building 116, recreation**

A wood frame building set on concrete piers. Entry was via steps, supported by piers, set in the southwest corner of the building (Figure 115 and Figure 116).

**CONCRETE PIERS**

**CALICHE WALWAY**

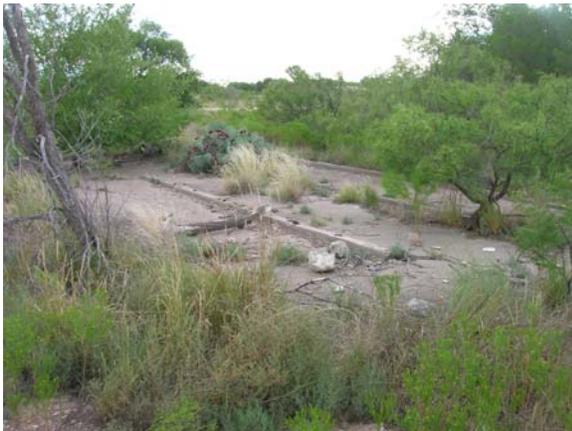
**Figure 117: Concrete slab of Building 118, lavatory**

The type L-5 lavatory is similar in plan to the type L-4; however, it is larger, measuring 50 x 25 feet (Figure 115 and Figure 117). It was associated with squadron barracks.

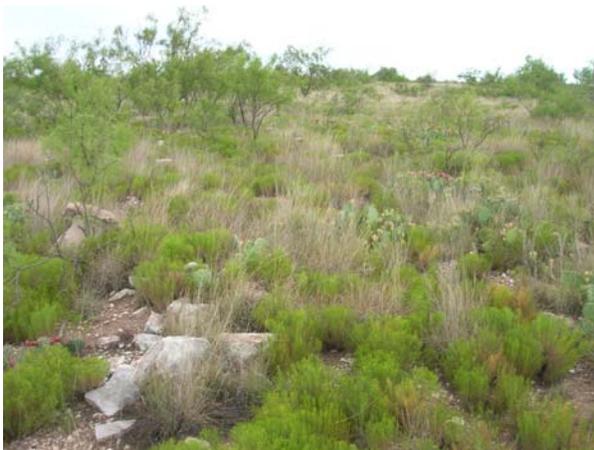
**Figure 118: Features of Building 124, enlisted men barracks**

This building was identical to other E.M.-32 buildings (Figure 118).

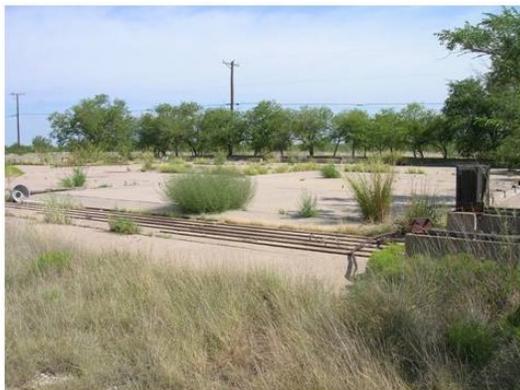
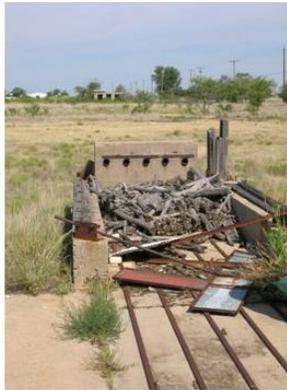
Figure 120: Features of Building 211, bomb trainer

See description for Buildings 201, 202 in Section 4.10.1. Figure 119 and Figure 120 shows the remains that are typical for these three structures.

CONCRETE SLAB WITH DOOR TRACKS

TRACKS & DOOR BAY

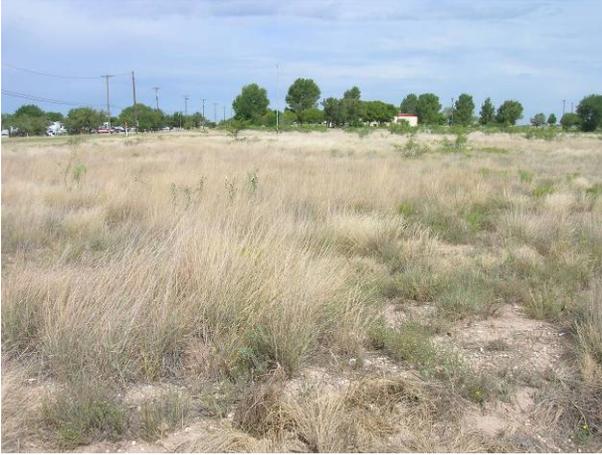
The area has been heavily disturbed and only one building foundation was found intact (Building 373 – a lavatory). The construction of the headquarters for the National Soaring Society in the southeast corner of 10th and A streets has completely removed all evidence of the squadron living area (Figure 122). An RV parking area for McAdams Park removed the foundations for the buildings facing the flight line. The alignment of B Street south of 13th Street realigned when the golf course was constructed which removed a number of squadron buildings.

**Figure 122: View to the northwest of Area L. The National Soaring Society building can be seen just in front of the tree line in the center of the photo. The power lines to the left follow the alignment of A Street.**

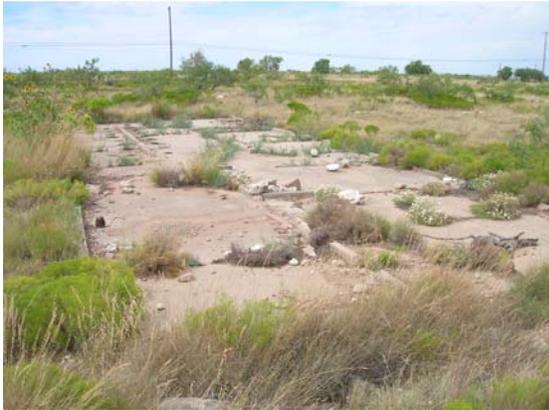
The type L-5 lavatory is similar in plan to the type L-4; however, it is larger, measuring 50 x 25 feet (Figure 123 and Figure 124). Both lavatories were associated with squadron barracks.

**Figure 123: Features of Building 368, lavatory**

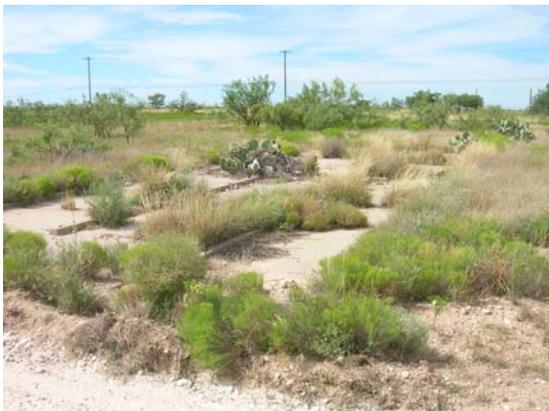
**Figure 124: Features of Building 373, lavatory**

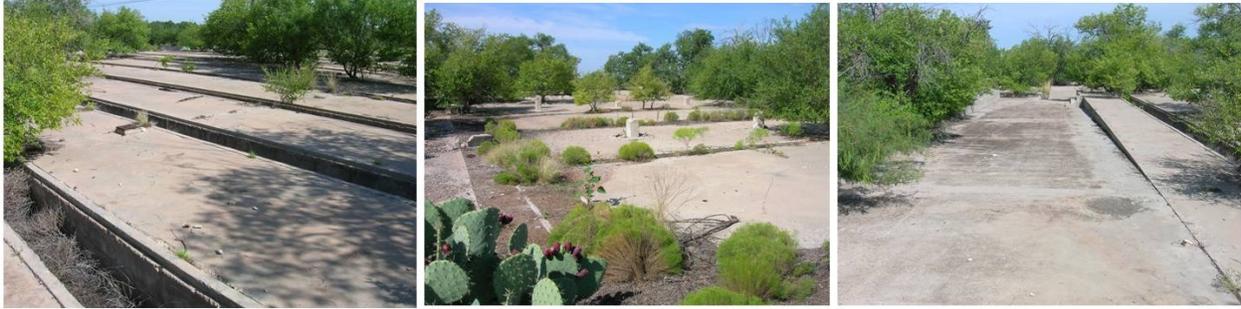
The Base Engineering Shop, measuring 300 x 180 feet, was one of the largest buildings on HAAF (Figure 126 - 129). The building was set on a concrete slab as high as three feet above ground level. It features two distinct areas: (1) the north half of the structure has concrete slab cut by deep floor drains (16 inches wide and 16 inches deep); and (2) the south half consisting of concrete slab without obstructions. A concrete ramp slopes up from north to south through the center of the building to connect the north and south ends. Loading docks are located on the south and west sides. A sewer system runs underneath the building, which is serviced through a hatchway located in the ramp. A large, pull-through hangar (Building 246) was attached to the west side of the structure. The foundations of an unidentified structure (no building number) once located inside Building 246 sits on the parking apron.

CONCRETE FLOOR WITH DRAINS      CONCRETE SLAB WITH PIERS      CONCRETE RAMP  
**Figure 127: Features of Building 234, Base Engineering Shop**

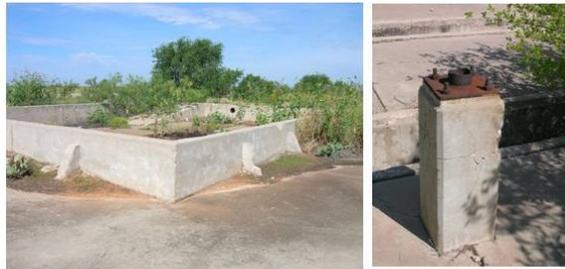
OUTBUILDING FOUNDATION      PIER DETAIL  
**Figure 128: Additional features of Building 234, Base Engineering Shop**

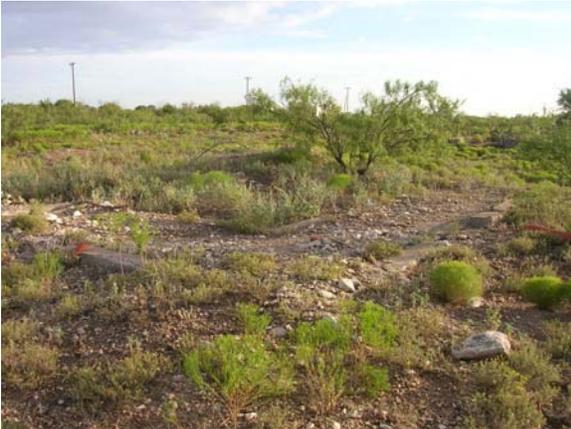
A small building measuring 20 x 25 feet with a rectangular section set below slab grade (Figure 132).

**Figure 133: Features of Building 548, oil storage system**

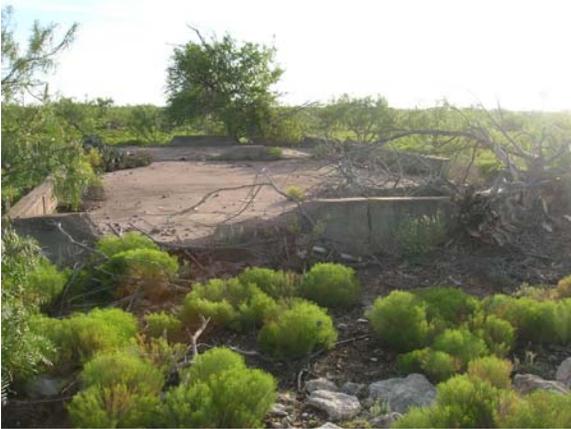
These identical buildings have two interior, non-connecting rooms that have their own separate entrances. A concrete slab, probably a loading dock, is situated on the structure's west side where a cluster of gas pipes are located (Figure 134). The loading docks face the railroad spur line # 1.

**Figure 134: Concrete foundation of Building 556, dope & oil storage**

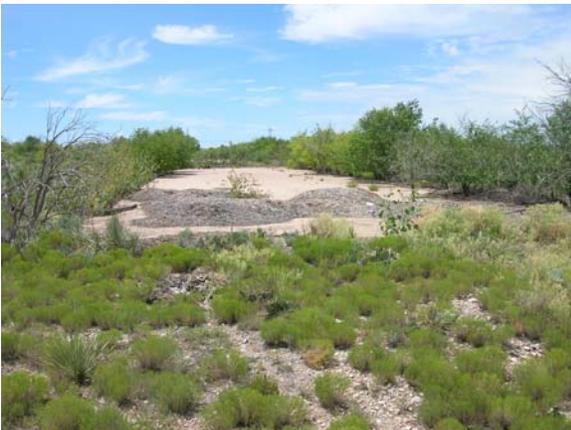
The only remains of the large warehouses in Area N are concrete slabs poured at grade (Figure 135 and Figure 136).

**Figure 135: Features of Building 561, Quartermaster Warehouse**

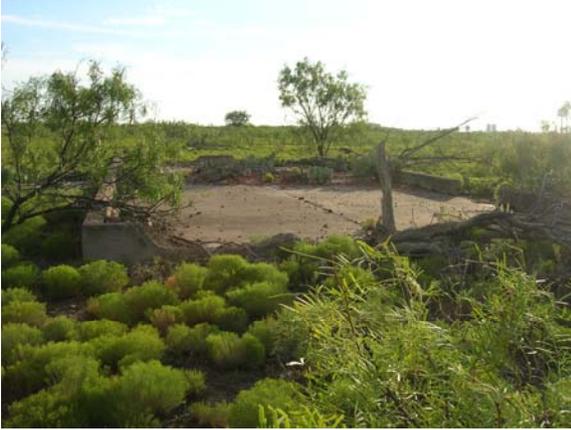
Figure 136: Concrete foundation of Building 566, dope & oil storage

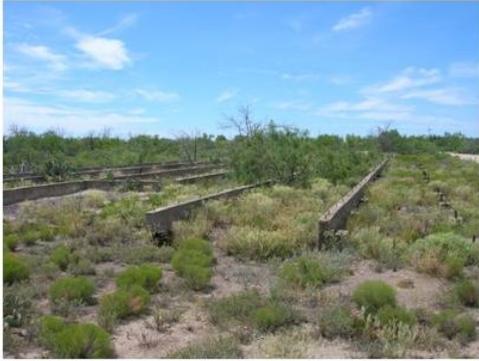
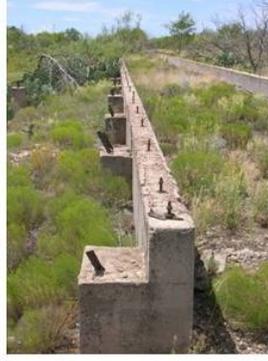
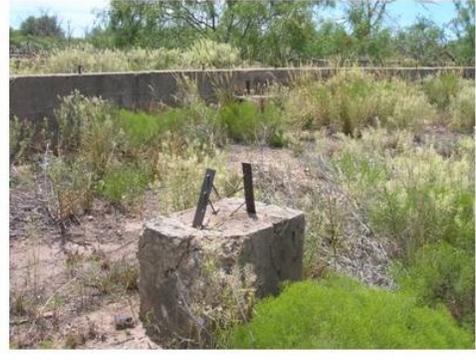
**Figure 138: Features of Building 570, commissary**

The commissary consists of six parallel rows of concrete stem walls, approximately 36 inches high (Figure 137). These walls are flanked on either side of the building by concrete piers representing porch supports. It is not known if these porches were enclosed or just covered. A concrete slab at grade at the center of the building probably represents a loading area. Remnants of reinforced concrete flooring were found piled on the foundations at the southwest end of the building (Figure 138).

**CONCRETE STEM WALLS & PIERS**

**STEM WALL**

**PORCH PIER**

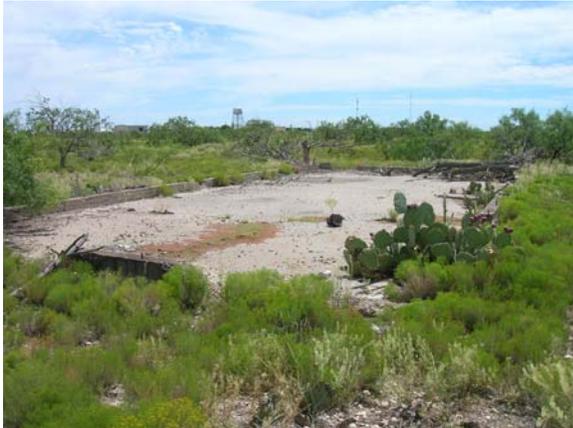
The remains of this building are a simple, rectangular structure on a concrete slab foundation (Figure 139).

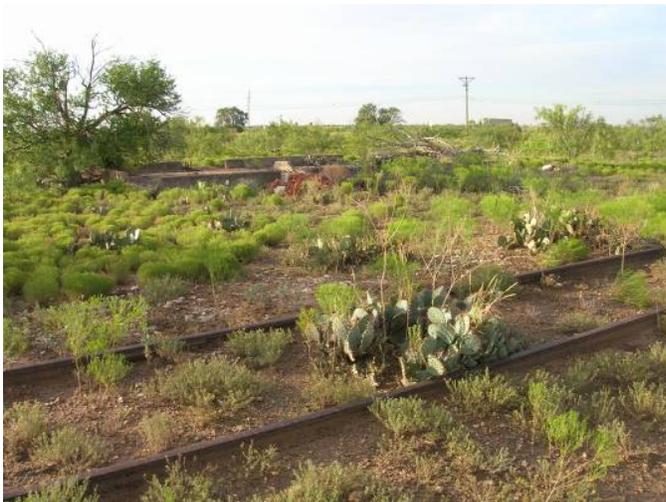
There still remain sections of the six railroad spur tracks that served the Sub-Depot (Figure 140).

**Figure 140: Remaining railroad tracks**

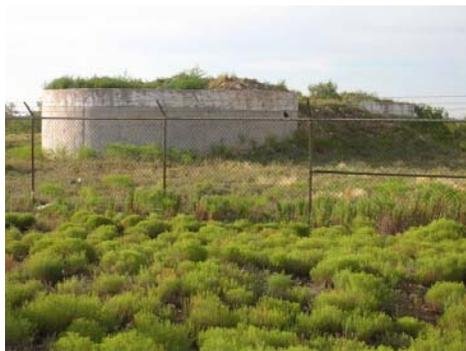
The sewage disposal plant consisted of two Imhoff tanks, three parallel leach fields and other miscellaneous structures (Figure 141). It served the entire HAAF. As of August 2007, the Imhoff tanks were still in place, but the system as a whole had been abandoned (Figure 142).

Figure 142: View to the south of the Imhoff tanks.

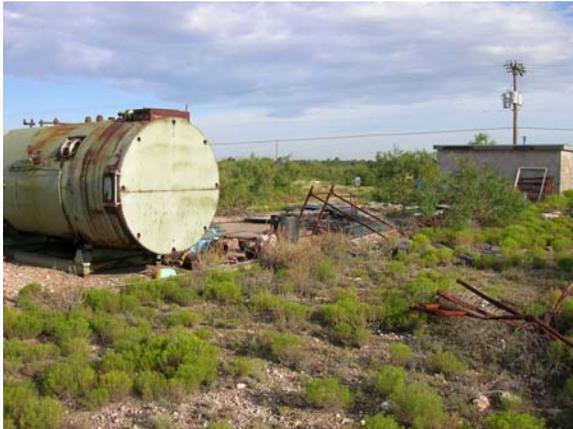
The only remains of the storehouse are a rectangular concrete slab and a small concrete auxiliary building. It is not known if the large steel tank on the site belongs to the HAAF period of use (Figure 144).

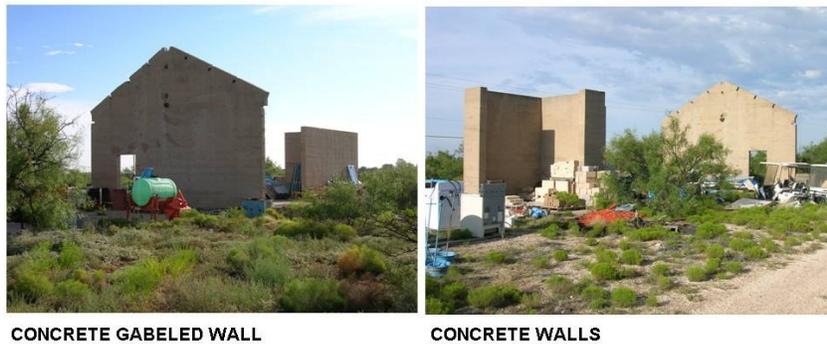
CONCRETE GABLED WALL      CONCRETE WALLS  
**Figure 145: Features of Building 581, Assembly & Maintenance (small arms)**

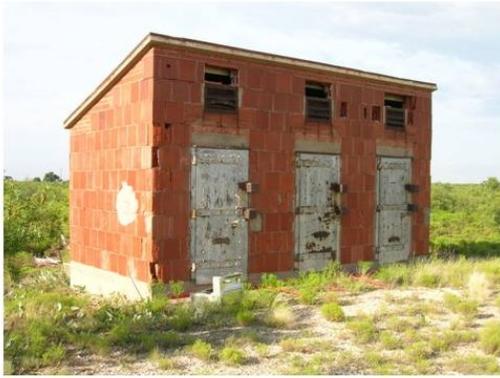
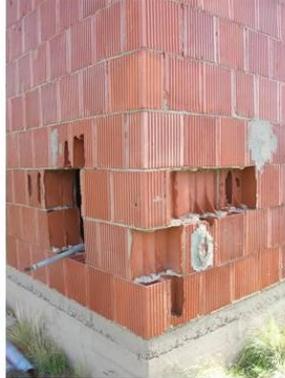
**Figure 146: Features of Building 582, segregated storage**

This standing, three-bay building is rectangular in shape with a shed roof (Figure 146). The doors are heavy steel with ventilation openings near the roofline. The building is constructed of hollow clay tile and brick (used for infill near the roof) set on a concrete block foundation.

**SHED ROOF, 3 BAY STRUCTURE**

**HOLLOW CLAY TILE DETAIL**

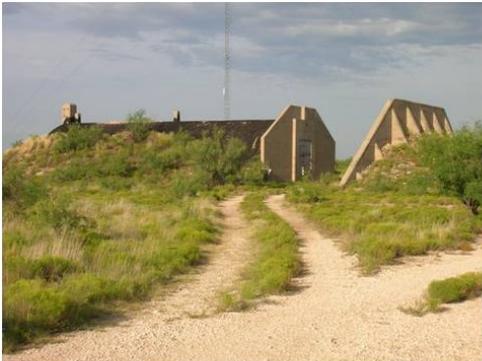
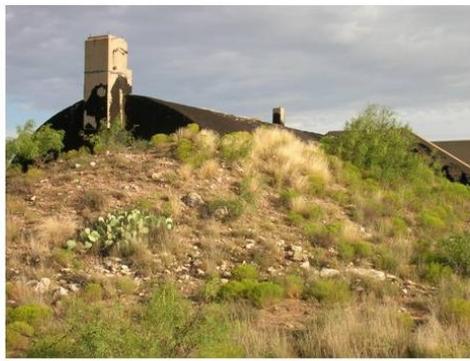
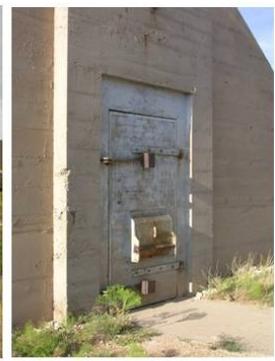
**Figure 147: Features of Building 583, underground magazine**

These two buildings are typical “Igloo” styles ordnance storage buildings. They feature heavy, steel doors, and a concrete structure partially covered with earth. A delivery road serves the door, which protected on the other side by a concrete blast shield (Figure 147 and Figure 148).

**MAGAZINE WITH BLAST SHIELD**

**CONCRETE ARCH & VENT DETAIL**

**MAGAZINE DOOR**

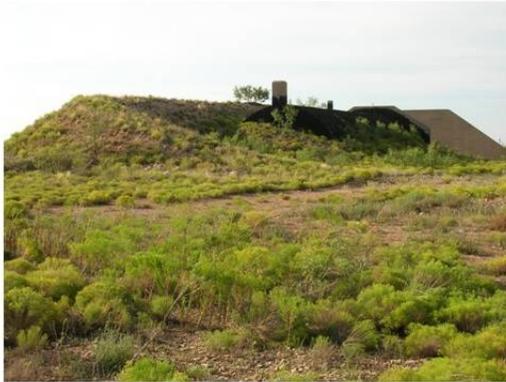
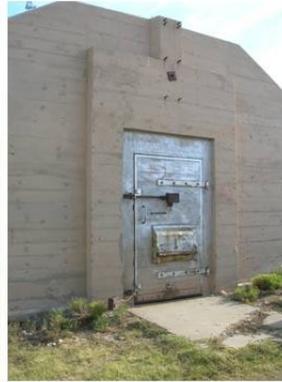
**Figure 148: Features of Building 590, underground magazine**

**CONCRETE ARCH & VENT**

**MAGAZINE DOOR**

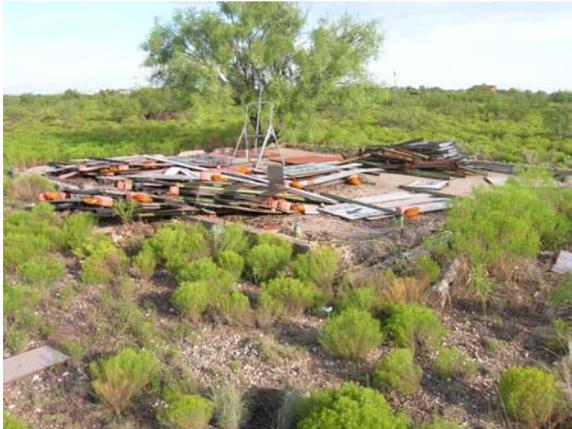
The only remaining evidence of this building is the concrete slab (Figure 149).

**Figure 149: Features of Building 591, chemical storage**

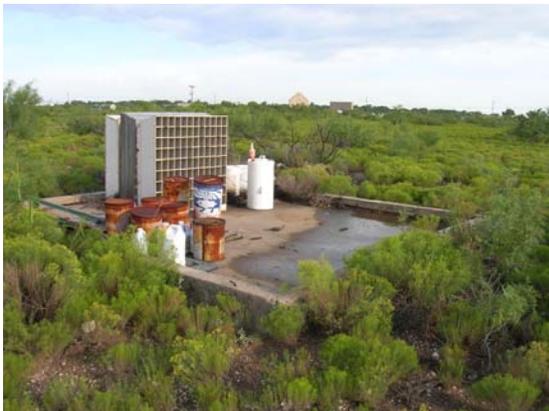
This is small building that once rested on a concrete slab (Figure 150).

**Figure 150: Features of Building 592, pyrotechnic building**

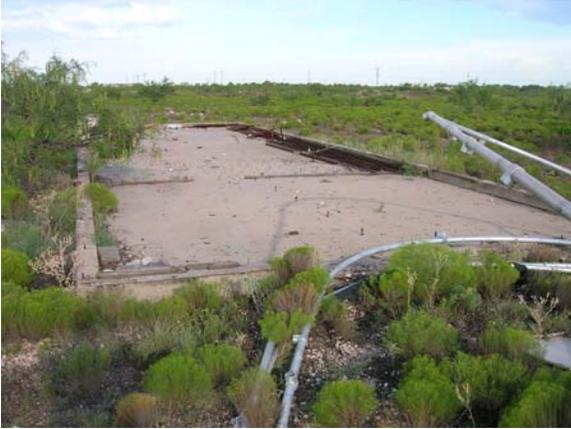
A long, rectangular building with two rooms, set on a concrete slab (Figure 151).

**Figure 151: Features of Building 593, small arms**
